Access Compliance Report Public Rights-of-Way (Curb Ramps)

Intersection ID: 27	7422 Main St	eet: BALLANTYNE_COMMONS_PY Cross Street: STONEBRIAR_DR						Location:	NE	
ADA ID: 1BD74AE29509 Ramp Ty		ype: Perp	Initial I	Initial Pass/Fail: Fail Overall Compliance: No				o Severity Score:	42.5	
Codes/Mitigation Info/Possible Solution					Field Measurements/Component Compliance					
	Carl Barris 1 1 + 1	Possible Solutions:		Compliance Description Da			ata Compliance Description		Data	
		Remove & Replace Entire Ram	ip.	N/A	Ramp Length (in)	110.0	No	Ramp Slope (%)	9.2

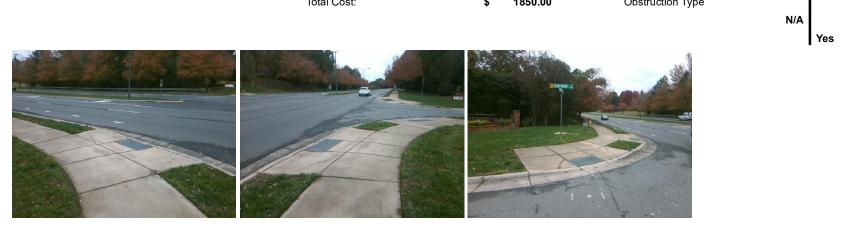
•	No	Ramp Width (in)	34.0	No	Ramp XSlope (%)	5.6	
				N/A	Flare Type LT	N/A	N/A	Flare Type RT	N/A	
A States	A PARTY A			N/A	Flare Slope LT (%)	N/A	N/A	Flare Slope RT (%)	N/A	
S The				N/A	Flare Traversable LT?	N/A	N/A	Flare Traversable RT?	N/A	
				N/A	Landing Length (in)	N/A	N/A	DWS Provided?	N/A	
		Surveyor Notes:		N/A	Landing Width (in)	N/A	N/A	DWS Contrast?	N/A	
<u>د.</u>		N/A		N/A	Landing Slope (%)	N/A	N/A	DWS Length (in)	N/A	
~ ~				N/A	Landing X Slope (%)	N/A	N/A	DWS Full Width?	N/A	
	BALLANTYNE COMMONS PY			N/A	Landing Curb? (Y/N)	N/A	N/A	DWS Offset (in)	N/A	
				N/A	Shared Landing?	N/A				
The second second second		PROW/ADA:		N/A	Gutter Ponding?	N/A	N/A	Gutter Slope (%)	N/A

C. C.		Not Found, R304.5.1, R304.2.2, R304.5.3)	N/A	Gutter Lip Ht (in)	N/A	N/A	Gutter X Slope (%)	N/A	
	A Contraction		,	N/A	Painted X Walk1?	No	N/A	Painted X Walk2?	N/A	
	19- a la st				X Walk 1 Direction	To S		X Walk 2 Direction	N/A	
	1/4 3 4 9 8 10			N/A	X Walk 1 Width (in)	N/A	N/A	X Walk 2 Width (in)	N/A	
Street 1 Name	BALLANTYNE COMMONS PY				X Walk 1 Slope (%)	4.1		X Walk 2 Slope (%)	N/A	
Stop Condition-Street 2	None				X Walk 1 X Slope (%)	3.3		X Walk 2 X Slope (%)	N/A	
Street 2 Name	N/A			N/A	Ramp inside XWalk1?	N/A	N/A	Ramp inside XWalk2?	N/A	
Stop Condition-Street 1	N/A				Road Slope (%)	N/A	N/A	Clear Space?	N/A	
					Road X Slope (%)	N/A	N/A	Clear Space to XWalk (in)	N/A	
				N/A	Any Obstructions?	N/A	N/A	Storm Grate/Utility Hazard?	N/A	
		Total Cost: \$	1850.00		Obstruction Type			Storm Grate/Utility Type		
						N/A			N/A
