Access Compliance Report

Public Rights-of-Way

(Curb Ramps)

Intersection ID: 31296	Main Street: DEERTON_RD	Cross Street: MELSTRAND_WY	Location:	N
ADA ID: 1BDE99D2078F	Ramp Type: PerpDiag	Initial Pass/Fail: Fail	Overall Compliance: No	Severity Score: 33.75

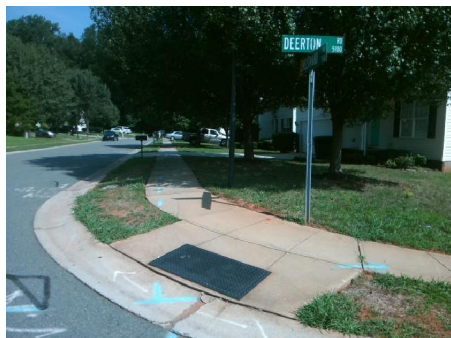
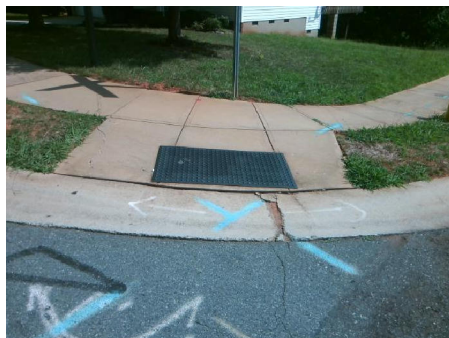
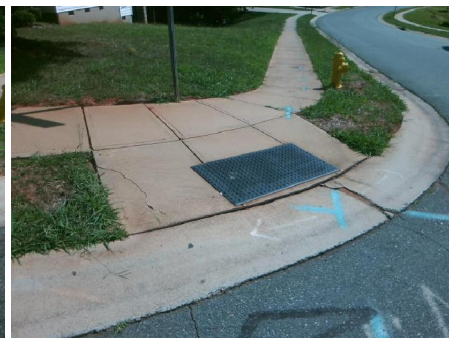
Compliance	Description	Data	Compliance	Description	Data
N/A	Ramp Length (in)	48.5	Yes	Ramp Slope (%)	6.8
No	Ramp Width (in)	36.5	No	Ramp XSlope (%)	8.1
N/A	Flare Type LT	N/A	N/A	Flare Type RT	N/A
N/A	Flare Slope LT (%)	N/A	N/A	Flare Slope RT (%)	N/A
N/A	Flare Traversable LT?	N/A	N/A	Flare Traversable RT?	N/A
N/A	Landing Length (in)	N/A	N/A	DWS Provided?	N/A
N/A	Landing Width (in)	N/A	N/A	DWS Contrast?	N/A
N/A	Landing Slope (%)	N/A	N/A	DWS Length (in)	N/A
N/A	Landing X Slope (%)	N/A	N/A	DWS Full Width?	N/A
N/A	Landing Curb? (Y/N)	N/A	N/A	DWS Offset (in)	N/A
N/A	Shared Landing?	N/A			
N/A	Gutter Ponding?	N/A	N/A	Gutter Slope (%)	N/A
N/A	Gutter Lip Ht (in)	N/A	N/A	Gutter X Slope (%)	N/A
N/A	Painted X Walk1?	No	N/A	Painted X Walk2?	No
	X Walk 1 Direction	To SW		X Walk 2 Direction	To SE
N/A	X Walk 1 Width (in)	N/A	N/A	X Walk 2 Width (in)	N/A
	X Walk 1 Slope (%)	7.5		X Walk 2 Slope (%)	0.9
	X Walk 1 X Slope (%)	4.7		X Walk 2 X Slope (%)	8.5

N/A	Ramp inside XWalk1?	N/A	N/A	Ramp inside XWalk2?	N/A
	Road Slope (%)	6.5	N/A	Clear Space?	N/A
	Road X Slope (%)	7.3	N/A	Clear Space to XWalk (in)	N/A
N/A	Any Obstructions?	N/A	N/A	Storm Grate/Utility Hazard?	N/A
	Obstruction Type			Storm Grate/Utility Type	
		N/A			N/A
			Yes	Surface Condition? (G/P)	Good

Remove & Replace Curb Ramp With Two New Directional Ramps or Equivalent.
