Access Compliance Report

Public Rights-of-Way

(Curb Ramps)

Intersection ID: N/A	Main Street: CLANTON_RD	Cross Street: I-77_TO_CLANTON_RD	Location: NE
ADA ID: 1BE046BC7A97	Ramp Type: Perp	Initial Pass/Fail: Fail	Overall Compliance: No
			Severity Score: 13.75

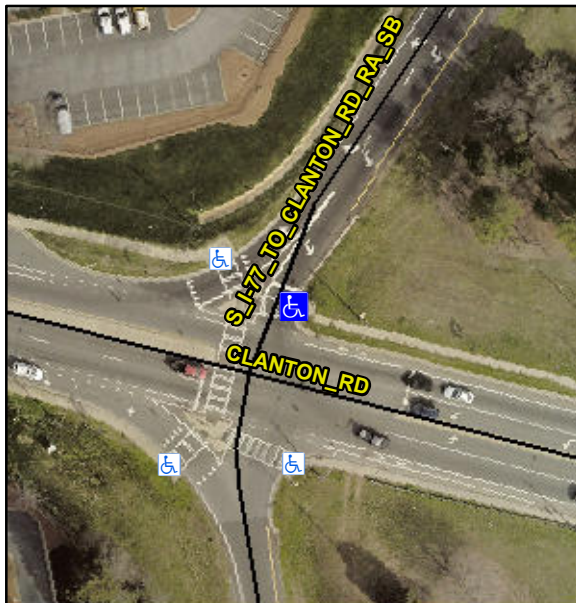
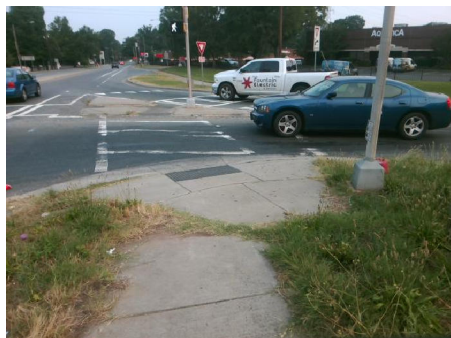
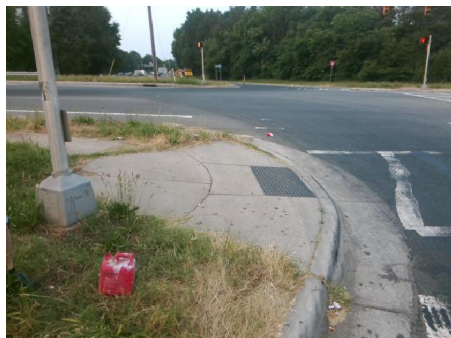
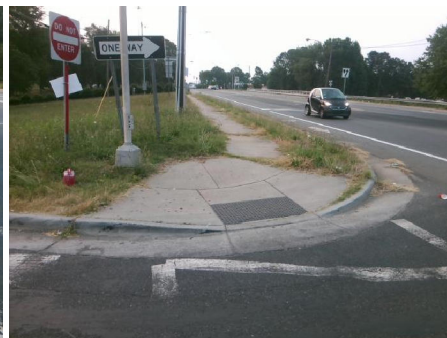
Not Found, R304.2.2, R304.5.3

Compliance	Description	Data	Compliance	Description	Data
N/A	Ramp Length (in)	120.0	No	Ramp Slope (%)	10.7
Yes	Ramp Width (in)	49.0	No	Ramp XSlope (%)	2.9
N/A	Flare Type LT	N/A	N/A	Flare Type RT	N/A
N/A	Flare Slope LT (%)	N/A	N/A	Flare Slope RT (%)	N/A
N/A	Flare Traversable LT?	N/A	N/A	Flare Traversable RT?	N/A
N/A	Landing Length (in)	N/A	N/A	DWS Provided?	N/A
N/A	Landing Width (in)	N/A	N/A	DWS Contrast?	N/A
N/A	Landing Slope (%)	N/A	N/A	DWS Length (in)	N/A
N/A	Landing X Slope (%)	N/A	N/A	DWS Full Width?	N/A
N/A	Landing Curb? (Y/N)	N/A	N/A	DWS Offset (in)	N/A
N/A	Shared Landing?	N/A			
N/A	Gutter Ponding?	N/A	N/A	Gutter Slope (%)	N/A
N/A	Gutter Lip Ht (in)	N/A	N/A	Gutter X Slope (%)	N/A
N/A	Painted X Walk1?	Yes	N/A	Painted X Walk2?	N/A
	X Walk 1 Direction	To W		X Walk 2 Direction	N/A
N/A	X Walk 1 Width (in)	109.0	N/A	X Walk 2 Width (in)	N/A
	X Walk 1 Slope (%)	2.5		X Walk 2 Slope (%)	N/A
	X Walk 1 X Slope (%)	0.5		X Walk 2 X Slope (%)	N/A

N/A	Ramp inside XWalk1?	Yes	N/A	Ramp inside XWalk2?	N/A
	Road Slope (%)	N/A	N/A	Clear Space?	N/A
	Road X Slope (%)	N/A	N/A	Clear Space to XWalk (in)	N/A
N/A	Any Obstructions?	N/A	N/A	Storm Grate/Utility Hazard?	N/A
	Obstruction Type			Storm Grate/Utility Type	
		N/A			N/A
			Yes	Surface Condition? (G/P)	Good

Remove & Replace Entire Ramp.
