# Access Compliance Report

## Public Rights-of-Way

### (Curb Ramps)

Intersection ID: 22962	Main Street: DEER_TRAIL_LN	Cross Street: HUNTERS_LANDING_DR	Location: S
ADA ID: 1BE0FEDB3AC1	Ramp Type: Perp	Initial Pass/Fail: Fail	Overall Compliance: No
			Severity Score: 13.75

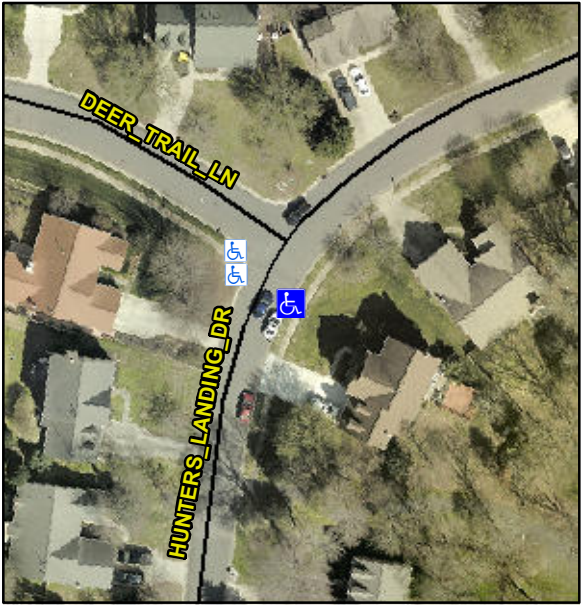
Possible Solutions:		<b>Compliance</b>	<b>Description</b>	<b>Data</b>
	<b>Remove &amp; Replace Entire Ramp.</b>		<b>No</b>	Ramp Length (in)	93.0
			<b>Yes</b>	Ramp Width (in)	67.0
			<b>N/A</b>	Flare Type LT	N/A
			<b>N/A</b>	Flare Slope LT (%)	N/A
			<b>N/A</b>	Flare Traversable LT?	N/A
			<b>N/A</b>	Landing Length (in)	N/A
			<b>N/A</b>	Landing Width (in)	N/A
			<b>N/A</b>	Landing Slope (%)	N/A
			<b>N/A</b>	Landing X Slope (%)	N/A
<p>Surveyor Notes:</p> <p><b>N/A</b></p> <p>PROW/ADA:</p> <p><b>Not Found, R304.2.2, R304.5.3</b></p>			<b>N/A</b>	Flare Type RT	N/A
			<b>N/A</b>	Flare Slope RT (%)	N/A
			<b>N/A</b>	Flare Traversable RT?	N/A
			<b>N/A</b>	DWS Provided?	N/A
			<b>N/A</b>	DWS Contrast?	N/A
			<b>N/A</b>	DWS Length (in)	N/A
			<b>N/A</b>	DWS Full Width?	N/A
			<b>N/A</b>	DWS Offset (in)	N/A
			<b>N/A</b>	Shared Landing?	N/A

<b>N/A</b>	Gutter Ponding?	N/A
			<b>N/A</b>	Gutter Lip Ht (in)	N/A
			<b>N/A</b>	Painted X Walk1?	No
				X Walk 1 Direction	To NW
			<b>N/A</b>	X Walk 1 Width (in)	N/A
				X Walk 1 Slope (%)	4.7
				X Walk 1 X Slope (%)	1.8
			<b>N/A</b>	Ramp inside XWalk1?	N/A
			<b>N/A</b>	Road Slope (%)	N/A
			<b>N/A</b>	Road X Slope (%)	N/A
			<b>N/A</b>	Any Obstructions?	N/A
				Obstruction Type	
			<b>N/A</b>		
			<b>N/A</b>		
			<b>N/A</b>		
			<b>N/A</b>		
			<b>N/A</b>		
			<b>N/A</b>		
			<b>N/A</b>		
			<b>N/A</b>		
			<b>N/A</b>		
Total Cost:		\$ 1850.00			
			<b>N/A</b>		
			<b>Yes</b>	Surface Condition? (G/P)	Good
