# Access Compliance Report

## Public Rights-of-Way

### (Curb Ramps)

Intersection ID: N/A	Main Street: MONROE_RD	Cross Street: KNICKERBOCKER_DR	Location: SE
ADA ID: 1BE35574A615	Ramp Type: Directional1	Initial Pass/Fail: Fail	Overall Compliance: No
Severity Score: 12.5			
Codes/Mitigation Info/Possible Solution		Field Measurements/Component Compliance

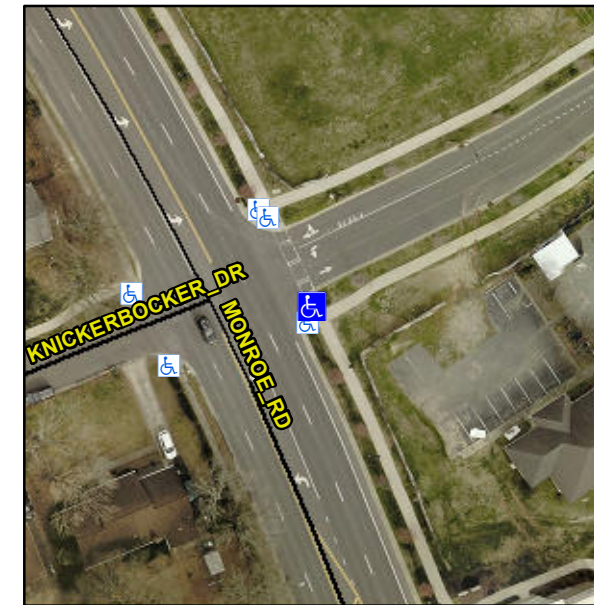
Compliance	Description	Data	Compliance	Description	Data
N/A	Ramp Length (in)	79.0	N/A	Grade Break?	N/A
Yes	Ramp Width (in)	65.0	N/A	Grade Break Slope (%)	0.0
No	Ramp Slope (%)	9.7	N/A	Grade Break XSlope (%)	0.0
Yes	Ramp XSlope (%)	1.0			
N/A	Flare Type LT	N/A	N/A	Flare Type RT	N/A
N/A	Flare Slope LT (%)	N/A	N/A	Flare Slope RT (%)	0.0
N/A	Flare Traversable LT?	N/A	N/A	Flare Traversable RT?	N/A
N/A	Landing Length (in)	0.0	N/A	DWS Provided?	N/A
N/A	Landing Width (in)	0.0	N/A	DWS Contrast?	N/A
N/A	Landing Slope (%)	0.0	N/A	DWS Length (in)	N/A
N/A	Landing X Slope (%)	0.0	N/A	DWS Full Width?	N/A
N/A	Landing Curb? (Y/N)	N/A	N/A	DWS Offset LT (in)	N/A
N/A	Shared Landing?	N/A	N/A	DWS Offset RT (in)	N/A
N/A	Gutter Ponding?	0.0	N/A	Gutter Slope (%)	N/A
N/A	Gutter Lip Ht (in)	0.0	N/A	Gutter X Slope (%)	N/A
N/A	Painted X Walk1?	Yes		Road Slope (%)	0.4
	X Walk 1 Direction	To NW		Road X Slope (%)	1.0
	X Walk 1 Width (in)	70.5		Clear Space?	N/A

X Walk 1 Slope (%)	0.4	N/A	Clear Space to XWalk (in)	N/A
	X Walk 1 X Slope (%)	1.0	N/A	Storm Grate/Utility Hazard?	N/A
N/A	Ramp inside XWalk1?	Yes		Storm Grate/Utility Type	
N/A	Any Obstructions?	N/A			N/A
	Obstruction Type		Yes	Surface Condition? (G/P)	Good
			N/A	Curb Slope (%)	6.3

**Remove & Replace Entire Ramp.**

**R304.2.2**

\$ 1600.00
