Access Compliance Report

Public Rights-of-Way

(Curb Ramps)

Intersection ID: 10353	Main Street: E_35TH_ST	Cross Street: N_MCDOWELL_ST	Location: E
ADA ID: 1BECAB99D1EF	Ramp Type: Perp	Initial Pass/Fail: Fail	Overall Compliance: No
Severity Score: 26.25			
Codes/Mitigation Info/Possible Solution		Field Measurements/Component Compliance

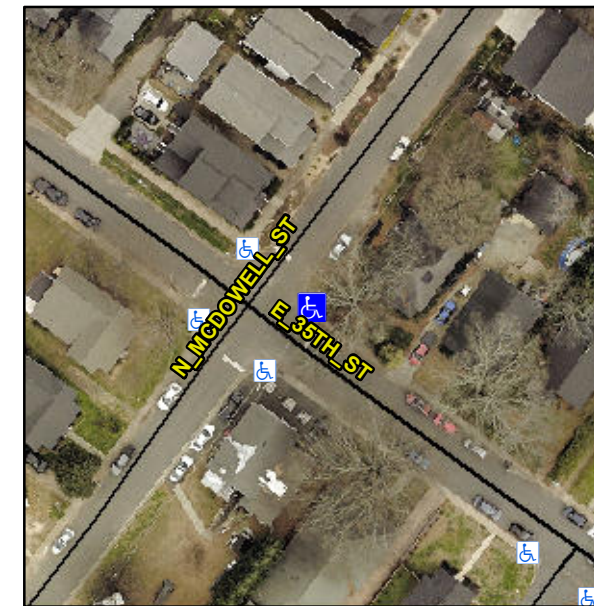
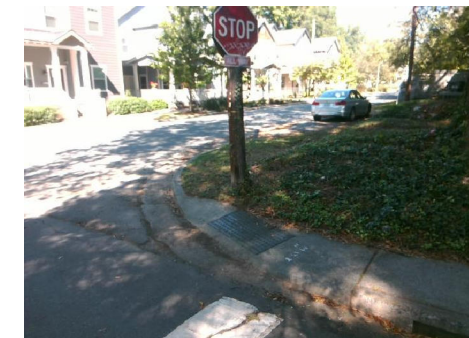
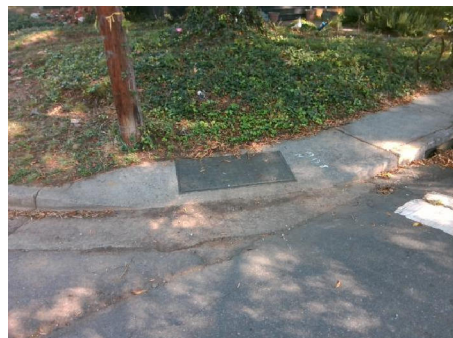
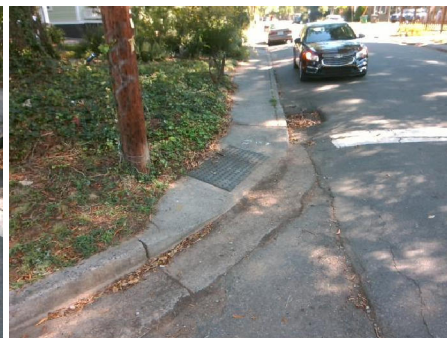
Not Found, R304.2.2, R304.5.3

Compliance	Description	Data	Compliance	Description	Data
N/A	Ramp Length (in)	36.5	No	Ramp Slope (%)	13.8
Yes	Ramp Width (in)	58.0	No	Ramp XSlope (%)	2.3
N/A	Flare Type LT	N/A	N/A	Flare Type RT	N/A
N/A	Flare Slope LT (%)	N/A	N/A	Flare Slope RT (%)	N/A
N/A	Flare Traversable LT?	N/A	N/A	Flare Traversable RT?	N/A
N/A	Landing Length (in)	N/A	N/A	DWS Provided?	N/A
N/A	Landing Width (in)	N/A	N/A	DWS Contrast?	N/A
N/A	Landing Slope (%)	N/A	N/A	DWS Length (in)	N/A
N/A	Landing X Slope (%)	N/A	N/A	DWS Full Width?	N/A
N/A	Landing Curb? (Y/N)	N/A	N/A	DWS Offset (in)	N/A
N/A	Shared Landing?	N/A			
N/A	Gutter Ponding?	N/A	N/A	Gutter Slope (%)	N/A
N/A	Gutter Lip Ht (in)	N/A	N/A	Gutter X Slope (%)	N/A
N/A	Painted X Walk1?	No	N/A	Painted X Walk2?	N/A
	X Walk 1 Direction	To NW		X Walk 2 Direction	N/A
N/A	X Walk 1 Width (in)	N/A	N/A	X Walk 2 Width (in)	N/A
	X Walk 1 Slope (%)	1.5		X Walk 2 Slope (%)	N/A
	X Walk 1 X Slope (%)	0.1		X Walk 2 X Slope (%)	N/A

N/A	Ramp inside XWalk1?	N/A	N/A	Ramp inside XWalk2?	N/A
	Road Slope (%)	N/A	N/A	Clear Space?	N/A
	Road X Slope (%)	N/A	N/A	Clear Space to XWalk (in)	N/A
N/A	Any Obstructions?	N/A	N/A	Storm Grate/Utility Hazard?	N/A
	Obstruction Type			Storm Grate/Utility Type	
		N/A			N/A
			Yes	Surface Condition? (G/P)	Good

Remove & Replace Entire Ramp.
