Intersection ID: 44302	Main Street: KIEV_DR	Cross Street: PAULINE_LN	Location:	SE
ADA ID: 1C09A6D56948	Ramp Type: PerpDiag	Initial Pass/Fail: Fail	Overall Compliance: No	Severity Score: 8.75

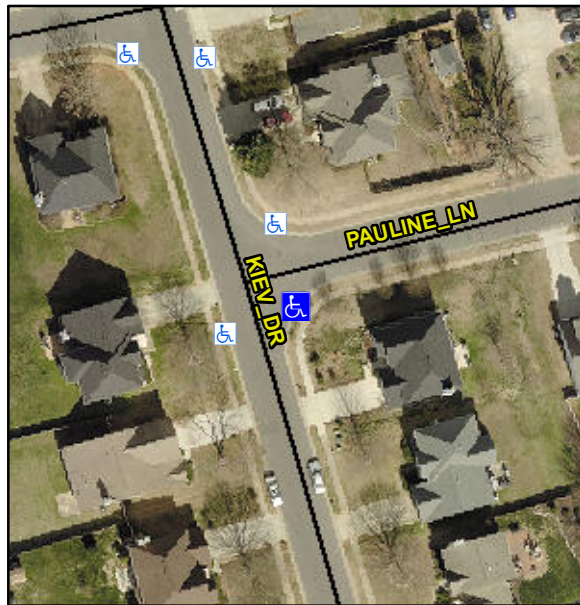
Compliance	Description	Data	Compliance	Description	Data
N/A	Ramp Length (in)	48.5	Yes	Ramp Slope (%)	7.0
No	Ramp Width (in)	46.0	Yes	Ramp XSlope (%)	0.9
N/A	Flare Type LT	N/A	N/A	Flare Type RT	N/A
N/A	Flare Slope LT (%)	N/A	N/A	Flare Slope RT (%)	N/A
N/A	Flare Traversable LT?	N/A	N/A	Flare Traversable RT?	N/A
N/A	Landing Length (in)	N/A	N/A	DWS Provided?	N/A
N/A	Landing Width (in)	N/A	N/A	DWS Contrast?	N/A
N/A	Landing Slope (%)	N/A	N/A	DWS Length (in)	N/A
N/A	Landing X Slope (%)	N/A	N/A	DWS Full Width?	N/A
N/A	Landing Curb? (Y/N)	N/A	N/A	DWS Offset (in)	N/A
N/A	Shared Landing?	N/A			
N/A	Gutter Ponding?	N/A	N/A	Gutter Slope (%)	N/A
N/A	Gutter Lip Ht (in)	N/A	N/A	Gutter X Slope (%)	N/A
N/A	Painted X Walk1?	No	N/A	Painted X Walk2?	No
	X Walk 1 Direction	To N		X Walk 2 Direction	To W
N/A	X Walk 1 Width (in)	N/A	N/A	X Walk 2 Width (in)	N/A
	X Walk 1 Slope (%)	0.9		X Walk 2 Slope (%)	3.5
	X Walk 1 X Slope (%)	2.8		X Walk 2 X Slope (%)	1.6

N/A	Ramp inside XWalk1?	N/A	N/A	Ramp inside XWalk2?	N/A
	Road Slope (%)	2.2	N/A	Clear Space?	N/A
	Road X Slope (%)	2.1	N/A	Clear Space to XWalk (in)	N/A
N/A	Any Obstructions?	N/A	N/A	Storm Grate/Utility Hazard?	N/A
	Obstruction Type			Storm Grate/Utility Type	
		N/A			N/A
			Yes	Surface Condition? (G/P)	Good

**Remove & Replace Curb Ramp With Two New Directional Ramps or Equivalent.**
