# Access Compliance Report

## Public Rights-of-Way

### (Curb Ramps)

Intersection ID: 14468	Main Street: E_TREMONT_AV	Cross Street: EUCLID_AV	Location: S
ADA ID: 1C0E44C66170	Ramp Type: PerpDiag	Initial Pass/Fail: Fail	Overall Compliance: No
		Severity Score: 12.5

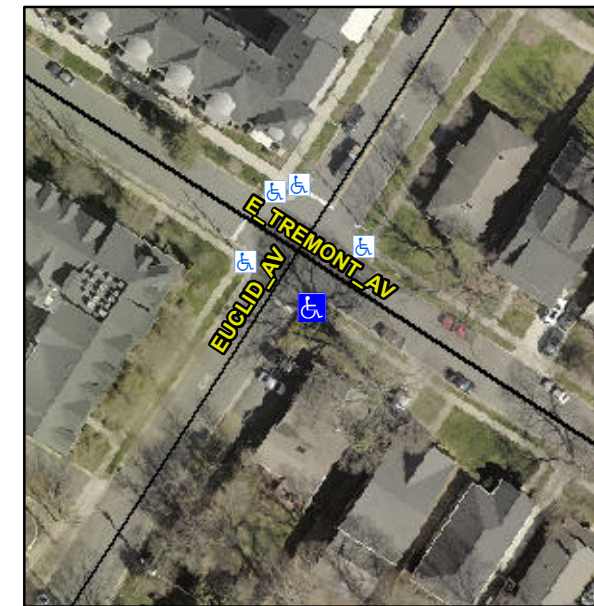
**Not Found, R304.5.3**

Compliance	Description	Data	Compliance	Description	Data
N/A	Ramp Length (in)	36.0	Yes	Ramp Slope (%)	8.3
Yes	Ramp Width (in)	48.0	No	Ramp XSlope (%)	6.1
N/A	Flare Type LT	N/A	N/A	Flare Type RT	N/A
N/A	Flare Slope LT (%)	N/A	N/A	Flare Slope RT (%)	N/A
N/A	Flare Traversable LT?	N/A	N/A	Flare Traversable RT?	N/A
N/A	Landing Length (in)	N/A	N/A	DWS Provided?	N/A
N/A	Landing Width (in)	N/A	N/A	DWS Contrast?	N/A
N/A	Landing Slope (%)	N/A	N/A	DWS Length (in)	N/A
N/A	Landing X Slope (%)	N/A	N/A	DWS Full Width?	N/A
N/A	Landing Curb? (Y/N)	N/A	N/A	DWS Offset (in)	N/A
N/A	Shared Landing?	N/A			
N/A	Gutter Ponding?	N/A	N/A	Gutter Slope (%)	N/A
N/A	Gutter Lip Ht (in)	1.0	N/A	Gutter X Slope (%)	N/A
N/A	Painted X Walk1?	No	N/A	Painted X Walk2?	No
	X Walk 1 Direction	To NE		X Walk 2 Direction	To NW
N/A	X Walk 1 Width (in)	N/A	N/A	X Walk 2 Width (in)	N/A
	X Walk 1 Slope (%)	5.9		X Walk 2 Slope (%)	6.4
	X Walk 1 X Slope (%)	3.9		X Walk 2 X Slope (%)	3.3

N/A	Ramp inside XWalk1?	N/A	N/A	Ramp inside XWalk2?	N/A
	Road Slope (%)	5.2	N/A	Clear Space?	N/A
	Road X Slope (%)	4.4	N/A	Clear Space to XWalk (in)	N/A
N/A	Any Obstructions?	N/A	N/A	Storm Grate/Utility Hazard?	N/A
	Obstruction Type			Storm Grate/Utility Type	
		N/A			N/A
		Yes		Surface Condition? (G/P)	Good

**Remove & Replace Curb Ramp With Two New Directional Ramps or Equivalent.**
