## **Access Compliance Report Public Rights-of-Way** (Curb Ramps)

Intersection ID: 2755 Main Street: BELL'S MILL DR **Cross Street: RIDGEFIELD DR** Location: N **ADA ID: 1C0F258CB00C** Ramp Type: Perp Initial Pass/Fail: Fail **Overall Compliance: No Severity Score:** 35

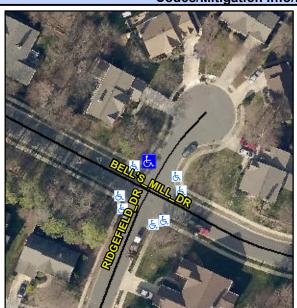
Field Measurements/Component Compliance							
	Compliance Description		Data	Compliance Description		Data	
	N/A	Ramp Length (in)	51.0	No	Ramp	Slope (%)	15.0
	No	Ramp Width (in)	38.0	No	Ramp	XSlope (%)	2.7
	N/A	Flare Type LT	N/A	N/A	Flare	Type RT	N/A
	N/A	Flare Slope LT (%)	N/A	N/A	Flare	Slope RT (%)	N/A
	N/A	Flare Traversable LT?	N/A	N/A	Flare	Traversable RT?	N/A
	N/A	Landing Length (in)	N/A	N/A	DWS	Provided?	N/A
	N/A	Landing Width (in)	N/A	N/A	DWS	Contrast?	N/A
	N/A	Landing Slope (%)	N/A	N/A	DWS	Length (in)	N/A
	N/A	Landing X Slope (%)	N/A	N/A	DWS	Full Width?	N/A
	N/A	Landing Curb? (Y/N)	N/A	N/A	DWS	Offset (in)	N/A
	N/A	Shared Landing?	N/A				
	N/A	Gutter Ponding?	N/A	N/A	Gutte	er Slope (%)	N/A
	N/A	Gutter Lip Ht (in)	N/A	N/A	Gutte	er X Slope (%)	N/A
	N/A	Painted X Walk1?	No	N/A	Paint	ed X Walk2?	N/A
		X Walk 1 Direction	To SE		X Wa	lk 2 Direction	N/A
	N/A	X Walk 1 Width (in)	N/A	N/A	X Wa	lk 2 Width (in)	N/A

X Walk 1 Slope (%)	2.8		X Wa	lk 2 Slope (%)	N/A
		X Walk 1 X Slope (%)	2.7		X Wa	lk 2 X Slope (%)	N/A
	N/A	Ramp inside XWalk1?	N/A	N/A	Ram	o inside XWalk2?	N/A
		Road Slope (%)	N/A	N/A	Clear	Space?	N/A
		Road X Slope (%)	N/A	N/A	Clear	Space to XWalk (in)	N/A
	N/A	Any Obstructions?	N/A	N/A	Storn	n Grate/Utility Hazard?	N/A
		Obstruction Type			Storn	n Grate/Utility Type	
			N/A				N/A
				Yes	Surfa	ce Condition? (G/P)	Good
	A STATE OF THE STA

RIDGEFIELD DR Street 1 Name Stop Condition-Street 2 StopSign Street 2 Name N/A Stop Condition-Street 1 N/A Possible Solutions: Remove & Replace Entire Ramp. Surveyor Notes: N/A PROW/ADA: R304.5.1, R304.2.2, R304.5.3

Total Cost: 1850.00
