Access Compliance Report

Public Rights-of-Way

(Curb Ramps)

Intersection ID: 15324	Main Street: ELMHURST_RD	Cross Street: SOUTH_BV	Location: SE
ADA ID: 1C1006BA3FC6	Ramp Type: Perp	Initial Pass/Fail: Fail	Overall Compliance: No
		Severity Score: 12.5

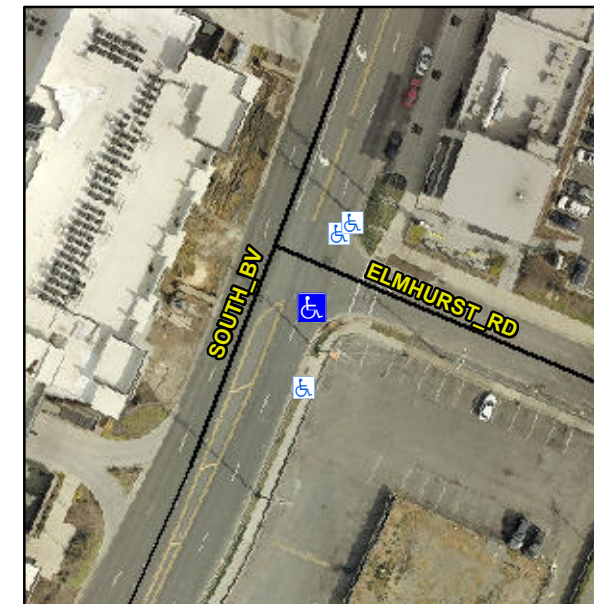
Compliance	Description	Data	Compliance	Description	Data
N/A	Ramp Length (in)	47.0	No	Ramp Slope (%)	11.2
Yes	Ramp Width (in)	48.0	Yes	Ramp XSlope (%)	1.7
N/A	Flare Type LT	N/A	N/A	Flare Type RT	N/A
N/A	Flare Slope LT (%)	N/A	N/A	Flare Slope RT (%)	N/A
N/A	Flare Traversable LT?	N/A	N/A	Flare Traversable RT?	N/A
N/A	Landing Length (in)	N/A	N/A	DWS Provided?	N/A
N/A	Landing Width (in)	N/A	N/A	DWS Contrast?	N/A
N/A	Landing Slope (%)	N/A	N/A	DWS Length (in)	N/A
N/A	Landing X Slope (%)	N/A	N/A	DWS Full Width?	N/A
N/A	Landing Curb? (Y/N)	N/A	N/A	DWS Offset (in)	N/A
N/A	Shared Landing?	N/A			
N/A	Gutter Ponding?	N/A	N/A	Gutter Slope (%)	N/A
N/A	Gutter Lip Ht (in)	N/A	N/A	Gutter X Slope (%)	N/A
N/A	Painted X Walk1?	Yes	N/A	Painted X Walk2?	N/A
	X Walk 1 Direction	To NE		X Walk 2 Direction	N/A
N/A	X Walk 1 Width (in)	112.0	N/A	X Walk 2 Width (in)	N/A
	X Walk 1 Slope (%)	1.3		X Walk 2 Slope (%)	N/A
	X Walk 1 X Slope (%)	1.2		X Walk 2 X Slope (%)	N/A

N/A	Ramp inside XWalk1?	Yes	N/A	Ramp inside XWalk2?	N/A
	Road Slope (%)	N/A	N/A	Clear Space?	N/A
	Road X Slope (%)	N/A	N/A	Clear Space to XWalk (in)	N/A
N/A	Any Obstructions?	N/A	N/A	Storm Grate/Utility Hazard?	N/A
	Obstruction Type			Storm Grate/Utility Type	
		N/A			N/A
		Yes		Surface Condition? (G/P)	Good

Possible Solutions:

Remove & Replace Entire Ramp.

R304.2.2
