Intersection ID: 13736	Main Street: CAMDEN_RD	Cross Street: E_PARK_AV	Location:	NW
ADA ID: 1C1D5D544F5A	Ramp Type: Perp	Initial Pass/Fail: Pass	Overall Compliance: No	Severity Score: 15

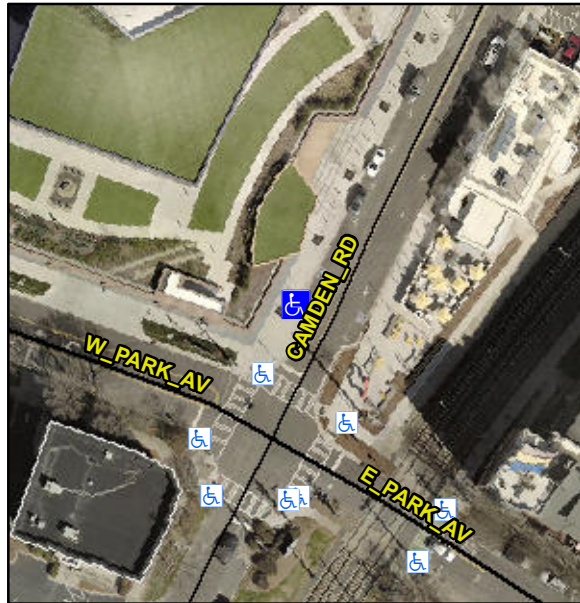
R304.2.3, R305

Compliance	Description	Data	Compliance	Description	Data
N/A	Ramp Length (in)	64.0	Yes	Ramp Slope (%)	8.3
Yes	Ramp Width (in)	52.0	Yes	Ramp XSlope (%)	1.8
No	Flare Type Curbed_WithWalkSurface		No	Flare Type RT	N/A
No	Flare Slope LT (%)	N/A	N/A	Flare Slope RT (%)	N/A
N/A	Flare Traversable LT?	No	N/A	Flare Traversable RT?	No
Yes	Landing Length (in)	62.0	No	DWS Provided?	No
Yes	Landing Width (in)	60.0	N/A	DWS Contrast?	No
Yes	Landing Slope (%)	0.7	N/A	DWS Length (in)	N/A
Yes	Landing X Slope (%)	1.5	N/A	DWS Full Width?	No
N/A	Landing Curb? (Y/N)	No	N/A	DWS Offset (in)	N/A
N/A	Shared Landing?	No			
Yes	Gutter Ponding?	No	Yes	Gutter Slope (%)	2.5
Yes	Gutter Lip Ht (in)	0.0	Yes	Gutter X Slope (%)	1.5
N/A	Painted X Walk1?	No	N/A	Painted X Walk2?	N/A
	X Walk 1 Direction	To NE		X Walk 2 Direction	N/A
N/A	X Walk 1 Width (in)	N/A	N/A	X Walk 2 Width (in)	N/A
	X Walk 1 Slope (%)	1.0		X Walk 2 Slope (%)	N/A
	X Walk 1 X Slope (%)	2.0		X Walk 2 X Slope (%)	N/A

N/A	Ramp inside XWalk1?	N/A	N/A	Ramp inside XWalk2?	N/A
	Road Slope (%)	N/A	N/A	Clear Space?	Yes
	Road X Slope (%)	N/A	N/A	Clear Space to XWalk (in)	N/A
Yes	Any Obstructions?	No	Yes	Storm Grate/Utility Hazard?	No
	Obstruction Type			Storm Grate/Utility Type	
		N/A			N/A
			Yes	Surface Condition? (G/P)	Good

Remove & Replace Entire Ramp.
