# Access Compliance Report

## Public Rights-of-Way

### (Curb Ramps)

Intersection ID: 14746	Main Street: ALBEMARLE_RD	Cross Street: WILGROVE_MINT_HILL_RD	Location: SW
ADA ID: 1C2281B0256F	Ramp Type: Perp	Initial Pass/Fail: Fail	Overall Compliance: No
Codes/Mitigation Info/Possible Solution		Field Measurements/Component Compliance

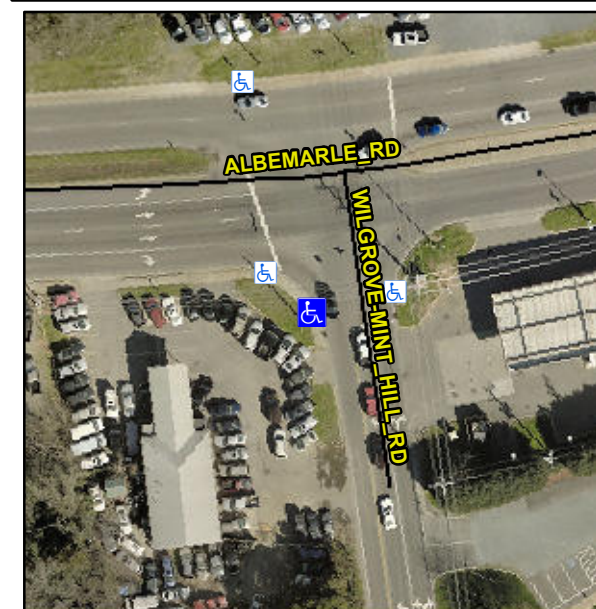
**Not Found, R304.5.1, R304.2.2**

Compliance	Description	Data	Compliance	Description	Data
N/A	Ramp Length (in)	58.0	No	Ramp Slope (%)	9.1
No	Ramp Width (in)	42.0	Yes	Ramp XSlope (%)	1.8
N/A	Flare Type LT	N/A	N/A	Flare Type RT	N/A
N/A	Flare Slope LT (%)	N/A	N/A	Flare Slope RT (%)	N/A
N/A	Flare Traversable LT?	N/A	N/A	Flare Traversable RT?	N/A
N/A	Landing Length (in)	N/A	N/A	DWS Provided?	N/A
N/A	Landing Width (in)	N/A	N/A	DWS Contrast?	N/A
N/A	Landing Slope (%)	N/A	N/A	DWS Length (in)	N/A
N/A	Landing X Slope (%)	N/A	N/A	DWS Full Width?	N/A
N/A	Landing Curb? (Y/N)	N/A	N/A	DWS Offset (in)	N/A
N/A	Shared Landing?	N/A			
N/A	Gutter Ponding?	N/A	N/A	Gutter Slope (%)	N/A
N/A	Gutter Lip Ht (in)	N/A	N/A	Gutter X Slope (%)	N/A
N/A	Painted X Walk1?	No	N/A	Painted X Walk2?	N/A
	X Walk 1 Direction	To E		X Walk 2 Direction	N/A
N/A	X Walk 1 Width (in)	N/A	N/A	X Walk 2 Width (in)	N/A
	X Walk 1 Slope (%)	0.8		X Walk 2 Slope (%)	N/A
	X Walk 1 X Slope (%)	1.0		X Walk 2 X Slope (%)	N/A

N/A	Ramp inside XWalk1?	N/A	N/A	Ramp inside XWalk2?	N/A
	Road Slope (%)	N/A	N/A	Clear Space?	N/A
	Road X Slope (%)	N/A	N/A	Clear Space to XWalk (in)	N/A
N/A	Any Obstructions?	N/A	N/A	Storm Grate/Utility Hazard?	N/A
	Obstruction Type			Storm Grate/Utility Type	
		N/A			N/A
			Yes	Surface Condition? (G/P)	Good

**Remove & Replace Entire Ramp.**
