# Access Compliance Report

## Public Rights-of-Way

### (Curb Ramps)

Intersection ID: 10023893	Main Street: COMMUNITY_HOUSE_RD	Cross Street: N/A	Location: NE
ADA ID: 1C32E3F6A725	Ramp Type: PerpDiag	Initial Pass/Fail: Fail	Overall Compliance: No
Codes/Mitigation Info/Possible Solution		Field Measurements/Component Compliance	
Severity Score: 8.75

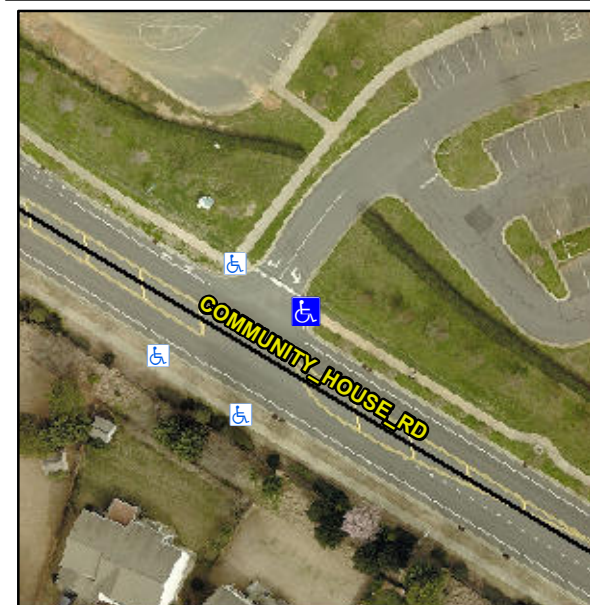
**Not Found, R304.5.1**

Compliance	Description	Data	Compliance	Description	Data
N/A	Ramp Length (in)	96.0	Yes	Ramp Slope (%)	5.9
No	Ramp Width (in)	45.0	Yes	Ramp XSlope (%)	1.3
N/A	Flare Type LT	N/A	N/A	Flare Type RT	N/A
N/A	Flare Slope LT (%)	N/A	N/A	Flare Slope RT (%)	N/A
N/A	Flare Traversable LT?	N/A	N/A	Flare Traversable RT?	N/A
N/A	Landing Length (in)	N/A	N/A	DWS Provided?	N/A
N/A	Landing Width (in)	N/A	N/A	DWS Contrast?	N/A
N/A	Landing Slope (%)	N/A	N/A	DWS Length (in)	N/A
N/A	Landing X Slope (%)	N/A	N/A	DWS Full Width?	N/A
N/A	Landing Curb? (Y/N)	N/A	N/A	DWS Offset (in)	N/A
N/A	Shared Landing?	N/A			
N/A	Gutter Ponding?	N/A	N/A	Gutter Slope (%)	N/A
N/A	Gutter Lip Ht (in)	N/A	N/A	Gutter X Slope (%)	N/A
N/A	Painted X Walk1?	No	N/A	Painted X Walk2?	No
	X Walk 1 Direction	To NW		X Walk 2 Direction	To SW
N/A	X Walk 1 Width (in)	N/A	N/A	X Walk 2 Width (in)	N/A
	X Walk 1 Slope (%)	0.2		X Walk 2 Slope (%)	2.8
	X Walk 1 X Slope (%)	1.2		X Walk 2 X Slope (%)	0.9

N/A	Ramp inside XWalk1?	N/A	N/A	Ramp inside XWalk2?	N/A
	Road Slope (%)	2.2	N/A	Clear Space?	N/A
	Road X Slope (%)	0.2	N/A	Clear Space to XWalk (in)	N/A
N/A	Any Obstructions?	N/A	N/A	Storm Grate/Utility Hazard?	N/A
	Obstruction Type			Storm Grate/Utility Type	
		N/A			N/A
			Yes	Surface Condition? (G/P)	Good

**Remove & Replace Curb Ramp With Two New Directional Ramps or Equivalent.**

Total Cost: \$ **3200.00**
