# Access Compliance Report

## Public Rights-of-Way

### (Curb Ramps)

Intersection ID: 31122	Main Street: MILLSTREAM RIDGE DR	Cross Street: LEGOLAS LN	Location: SW
ADA ID: 1C3BFE7F420F	Ramp Type: PerpDiag	Initial Pass/Fail: Fail	Overall Compliance: No
		Severity Score: 12.5

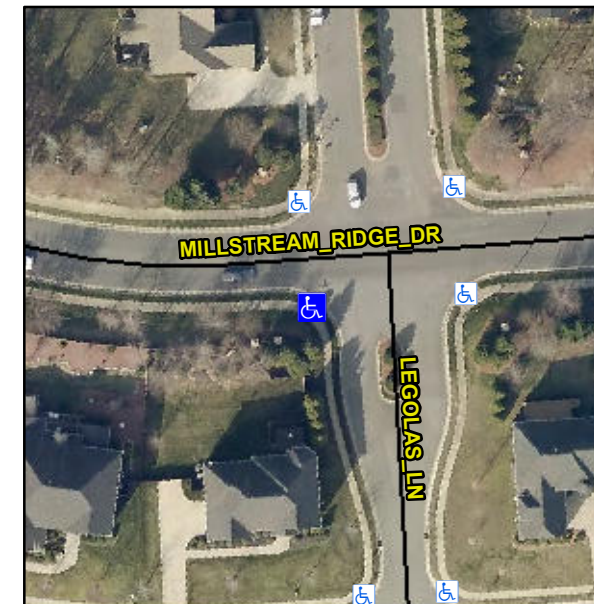
**Not Found, R304.5.3**

Compliance	Description	Data	Compliance	Description	Data
N/A	Ramp Length (in)	49.0	Yes	Ramp Slope (%)	5.2
Yes	Ramp Width (in)	48.0	No	Ramp XSlope (%)	6.6
N/A	Flare Type LT	N/A	N/A	Flare Type RT	N/A
N/A	Flare Slope LT (%)	N/A	N/A	Flare Slope RT (%)	N/A
N/A	Flare Traversable LT?	N/A	N/A	Flare Traversable RT?	N/A
N/A	Landing Length (in)	N/A	N/A	DWS Provided?	N/A
N/A	Landing Width (in)	N/A	N/A	DWS Contrast?	N/A
N/A	Landing Slope (%)	N/A	N/A	DWS Length (in)	N/A
N/A	Landing X Slope (%)	N/A	N/A	DWS Full Width?	N/A
N/A	Landing Curb? (Y/N)	N/A	N/A	DWS Offset (in)	N/A
N/A	Shared Landing?	N/A			
N/A	Gutter Ponding?	N/A	N/A	Gutter Slope (%)	N/A
N/A	Gutter Lip Ht (in)	0.5	N/A	Gutter X Slope (%)	N/A
N/A	Painted X Walk1?	No	N/A	Painted X Walk2?	No
	X Walk 1 Direction	To E		X Walk 2 Direction	To N
N/A	X Walk 1 Width (in)	N/A	N/A	X Walk 2 Width (in)	N/A
	X Walk 1 Slope (%)	4.4		X Walk 2 Slope (%)	1.8
	X Walk 1 X Slope (%)	4.3		X Walk 2 X Slope (%)	4.5

N/A	Ramp inside XWalk1?	N/A	N/A	Ramp inside XWalk2?	N/A
	Road Slope (%)	5.2	N/A	Clear Space?	N/A
	Road X Slope (%)	1.0	N/A	Clear Space to XWalk (in)	N/A
N/A	Any Obstructions?	N/A	N/A	Storm Grate/Utility Hazard?	N/A
	Obstruction Type			Storm Grate/Utility Type	
		N/A			N/A
		Yes		Surface Condition? (G/P)	Good

**Remove & Replace Curb Ramp With Two New Directional Ramps or Equivalent.**
