Access Compliance Report

Public Rights-of-Way

(Curb Ramps)

Intersection ID: N/A	Main Street: CRESSWIND BV	Cross Street: SHOFF CIR	Location: S
ADA ID: 1C3C762DB114	Ramp Type: BlendTrans1	Initial Pass/Fail: Fail	Overall Compliance: No
Severity Score: 25			
Codes/Mitigation Info/Possible Solution		Field Measurements/Component Compliance

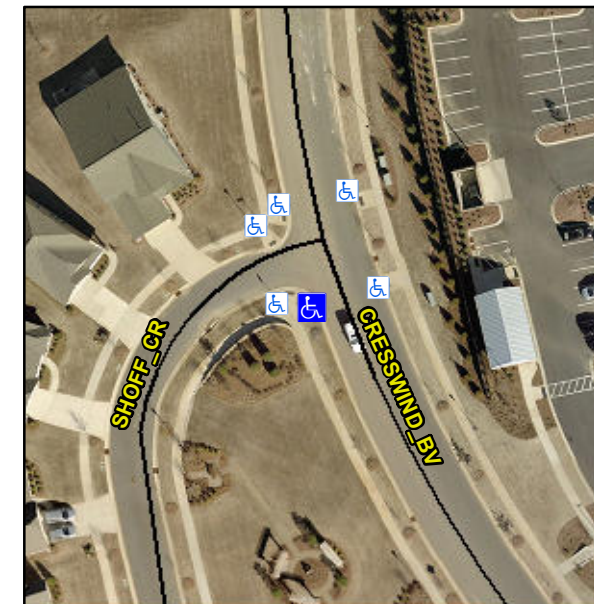
Not Found, R304.5.3

Compliance	Description	Data	Compliance	Description	Data
N/A	Ramp Length (in)	138.0	Yes	BlendTrans Slope (%)	3.3
Yes	Ramp Width (in)	60.0	No	BlendTrans XSlope (%)	8.5
N/A	Flare Type LT	N/A	N/A	Flare Type RT	N/A
N/A	Flare Slope LT (%)	N/A	N/A	Flare Slope RT (%)	N/A
N/A	Flare Traversable LT?	No	N/A	Flare Traversable RT?	No
N/A	Landing Length (in)	N/A	N/A	DWS Provided?	N/A
N/A	Landing Width (in)	N/A	N/A	DWS Contrast?	N/A
N/A	Landing Slope (%)	N/A	N/A	DWS Length (in)	N/A
N/A	Landing X Slope (%)	N/A	N/A	DWS Full Width?	N/A
N/A	Landing Curb? (Y/N)	N/A	N/A	DWS Offset (in)	N/A
N/A	Shared Landing?	N/A			
N/A	Gutter Ponding?	N/A	N/A	Gutter Slope (%)	N/A
N/A	Gutter Lip Ht (in)	1.0	N/A	Gutter X Slope (%)	N/A
N/A	Painted X Walk1?	No	N/A	Painted X Walk2?	N/A
	X Walk 1 Direction	To NE		X Walk 2 Direction	N/A
	X Walk 1 Width (in)	N/A		X Walk 2 Width (in)	N/A
	X Walk 1 Slope (%)	3.3		X Walk 2 Slope (%)	N/A
	X Walk 1 X Slope (%)	5.4		X Walk 2 X Slope (%)	N/A

N/A	Ramp inside XWalk1?	N/A	N/A	Ramp inside XWalk2?	N/A
	Road Slope (%)	5.4		Clear Space?	N/A
	Road X Slope (%)	3.3	N/A	Clear Space to XWalk (in)	N/A
N/A	Any Obstructions?	N/A	N/A	Storm Grate/Utility Hazard?	N/A
	Obstruction Type			Storm Grate/Utility Type	
		N/A			N/A
			Yes	Surface Condition? (G/P)	Good
			No	Curb Slope (%)	8.0

Possible Solutions:

Remove & Replace Curb Ramp With Two New Directional Ramps or Equivalent.
