Access Compliance Report

Public Rights-of-Way

(Curb Ramps)

Intersection ID: 18125	Main Street: BRANDYWINE_RD	Cross Street: CHELSEA_DR	Location: NE
ADA ID: 1C434431C04B	Ramp Type: PerpDiag	Initial Pass/Fail: Fail	Overall Compliance: No
			Severity Score: 33.75

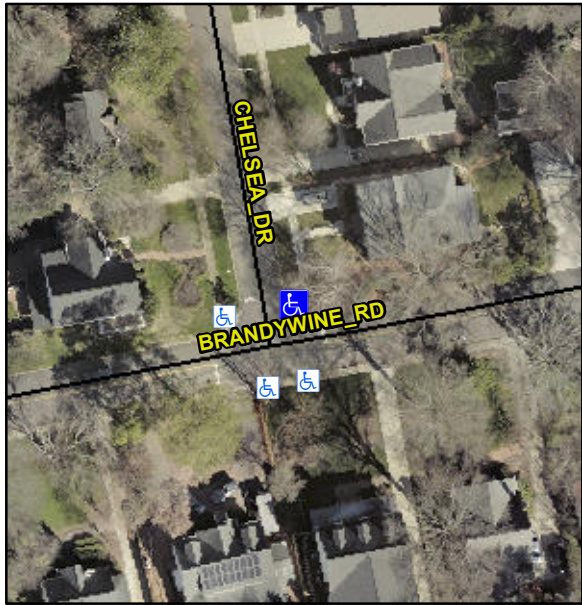
Possible Solutions:		Compliance	Description	Data	Compliance	Description	Data
	Remove & Replace Curb Ramp With Two New Directional Ramps or Equivalent.		N/A	Ramp Length (in)	166.0	Yes	Ramp Slope (%)	5.2
			No	Ramp Width (in)	45.0	No	Ramp XSlope (%)	12.2
			N/A	Flare Type LT	N/A	N/A	Flare Type RT	N/A
			N/A	Flare Slope LT (%)	N/A	N/A	Flare Slope RT (%)	N/A
			N/A	Flare Traversable LT?	N/A	N/A	Flare Traversable RT?	N/A
	Surveyor Notes:		N/A	Landing Length (in)	N/A	N/A	DWS Provided?	N/A
			N/A	Landing Width (in)	N/A	N/A	DWS Contrast?	N/A
			N/A	Landing Slope (%)	N/A	N/A	DWS Length (in)	N/A
			N/A	Landing X Slope (%)	N/A	N/A	DWS Full Width?	N/A
N/A			Landing Curb? (Y/N)	N/A	N/A	DWS Offset (in)	N/A	
PROW/ADA:		N/A	Shared Landing?	N/A				
		N/A	Gutter Ponding?	N/A	N/A	Gutter Slope (%)	N/A	
		N/A	Gutter Lip Ht (in)	N/A	N/A	Gutter X Slope (%)	N/A

N/A	Painted X Walk1?	No	N/A	Painted X Walk2?	No	
			X Walk 1 Direction	To W		X Walk 2 Direction	To S	
Total Cost: \$ 3200.00		N/A	X Walk 1 Width (in)	N/A	N/A	X Walk 2 Width (in)	N/A	
			X Walk 1 Slope (%)	0.8		X Walk 2 Slope (%)	8.3	
			X Walk 1 X Slope (%)	9.9		X Walk 2 X Slope (%)	2.0	
		N/A	Ramp inside XWalk1?	N/A	N/A	Ramp inside XWalk2?	N/A	
			Road Slope (%)	8.7	N/A	Clear Space?	N/A	
			Road X Slope (%)	6.4	N/A	Clear Space to XWalk (in)	N/A	
		N/A	Any Obstructions?	N/A	N/A	Storm Grate/Utility Hazard?	N/A	
			Obstruction Type			Storm Grate/Utility Type		
				N/A			N/A	
				Yes	Surface Condition? (G/P)	Good
