## Access Compliance Report Public Rights-of-Way (Curb Ramps)

Intersection ID: 10029825Main Street:KREFELD\_DRCross Street:N/ALocation:NWADA ID: 1C6F1B28F683Ramp Type:PerpDiagInitial Pass/Fail:FailOverall Compliance:NoSeverity Score:50

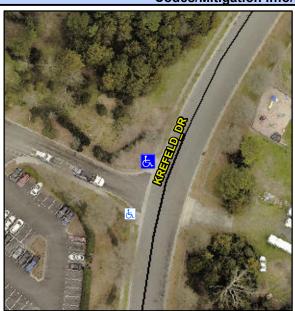
Comp	oliance Description	Data	Comp	liance Description	Data
N/A	Ramp Length (in)	60.0	No	Ramp Slope (%)	14.1
Yes	Ramp Width (in)	48.0	No	Ramp XSlope (%)	9.1
N/A	Flare Type LT	N/A	N/A	Flare Type RT	N/A
N/A	Flare Slope LT (%)	N/A	N/A	Flare Slope RT (%)	N/A
N/A	Flare Traversable LT?	N/A	N/A	Flare Traversable RT?	N/A
N/A	Landing Length (in)	N/A	N/A	DWS Provided?	N/A
N/A	Landing Width (in)	N/A	N/A	DWS Contrast?	N/A
N/A	Landing Slope (%)	N/A	N/A	DWS Length (in)	N/A
N/A	Landing X Slope (%)	N/A	N/A	DWS Full Width?	N/A
N/A	Landing Curb? (Y/N)	N/A	N/A	DWS Offset (in)	N/A
N/A	Shared Landing?	N/A			
N/A	Gutter Ponding?	N/A	N/A	Gutter Slope (%)	N/A
N/A	Gutter Lip Ht (in)	N/A	N/A	Gutter X Slope (%)	N/A
N/A	Painted X Walk1?	No	N/A	Painted X Walk2?	No
	X Walk 1 Direction	To S		X Walk 2 Direction	To E
N/A	X Walk 1 Width (in)	N/A	N/A	X Walk 2 Width (in)	N/A
	X Walk 1 Slope (%)	5.5		X Walk 2 Slope (%)	2.4
	X Walk 1 X Slope (%)	6.0		X Walk 2 X Slope (%)	3.6

N/A	Ramp inside XWalk1?	N/A	N/A	Ramp inside XWalk2?	N/A
	Road Slope (%)	5.5	N/A	Clear Space?	N/A
	Road X Slope (%)	6.4	N/A	Clear Space to XWalk (in)	N/A
N/A	Any Obstructions?	N/A	N/A	Storm Grate/Utility Hazard?	N/A
	Obstruction Type			Storm Grate/Utility Type	
		N/A			N/A

ENTRANCE StopSign KREFELD DR None Remove & Replace Curb Ramp With Two New Directional Ramps or Equivalent.

Not Found, R304.2.2, R304.5.3
