# Access Compliance Report

## Public Rights-of-Way

### (Curb Ramps)

Intersection ID: 29688	Main Street: BIG_PINE_DR	Cross Street: EQUESTRIAN_DR	Location: SE
ADA ID: 1C7E47EB618B	Ramp Type: BlendTrans1	Initial Pass/Fail: Fail	Overall Compliance: No
Severity Score: 8.75			
Codes/Mitigation Info/Possible Solution		Field Measurements/Component Compliance

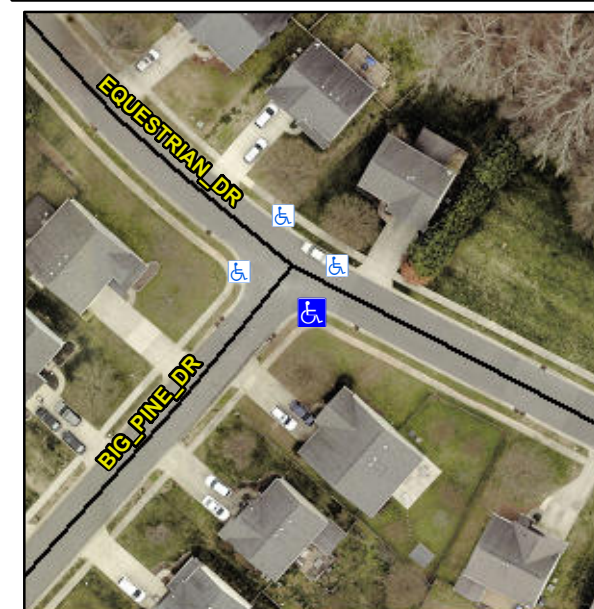
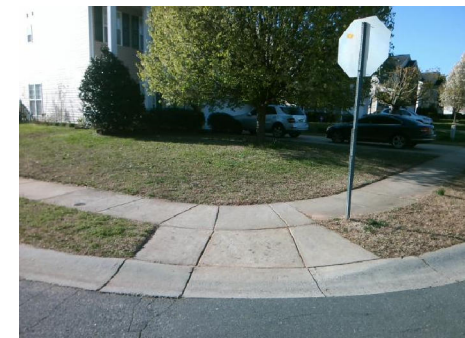
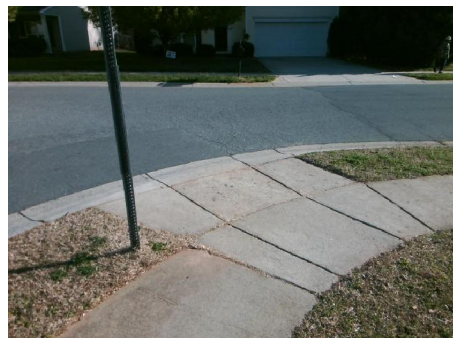
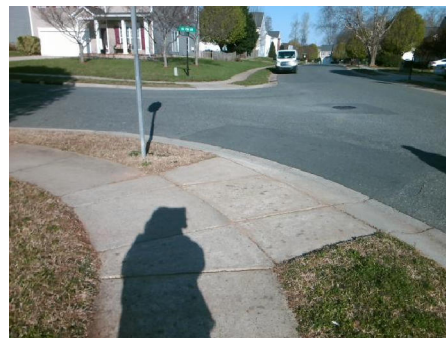
**Not Found, R304.5.1**

Compliance	Description	Data	Compliance	Description	Data
N/A	Ramp Length (in)	46.5	Yes	BlendTrans Slope (%)	3.2
No	Ramp Width (in)	42.0	Yes	BlendTrans XSlope (%)	1.8
N/A	Flare Type LT	N/A	N/A	Flare Type RT	N/A
N/A	Flare Slope LT (%)	N/A	N/A	Flare Slope RT (%)	N/A
N/A	Flare Traversable LT?	N/A	N/A	Flare Traversable RT?	N/A
N/A	Landing Length (in)	N/A	N/A	DWS Provided?	N/A
N/A	Landing Width (in)	N/A	N/A	DWS Contrast?	N/A
N/A	Landing Slope (%)	N/A	N/A	DWS Length (in)	N/A
N/A	Landing X Slope (%)	N/A	N/A	DWS Full Width?	N/A
N/A	Landing Curb? (Y/N)	N/A	N/A	DWS Offset (in)	N/A
N/A	Shared Landing?	N/A			
N/A	Gutter Ponding?	N/A	N/A	Gutter Slope (%)	N/A
N/A	Gutter Lip Ht (in)	N/A	N/A	Gutter X Slope (%)	N/A
N/A	Painted X Walk1?	No	N/A	Painted X Walk2?	No
	X Walk 1 Direction	To NE		X Walk 2 Direction	To NW
	X Walk 1 Width (in)	N/A		X Walk 2 Width (in)	N/A
	X Walk 1 Slope (%)	3.9		X Walk 2 Slope (%)	2.3
	X Walk 1 X Slope (%)	3.5		X Walk 2 X Slope (%)	2.6

N/A	Ramp inside XWalk1?	N/A	N/A	Ramp inside XWalk2?	N/A
	Road Slope (%)	2.4		Clear Space?	N/A
	Road X Slope (%)	5.3	N/A	Clear Space to XWalk (in)	N/A
N/A	Any Obstructions?	N/A	N/A	Storm Grate/Utility Hazard?	N/A
	Obstruction Type			Storm Grate/Utility Type	
		N/A			N/A
			Yes	Surface Condition? (G/P)	Good
			No	Curb Slope (%)	12.6

**Remove & Replace Curb Ramp With Two New Directional Ramps or Equivalent.**
