# Access Compliance Report

## Public Rights-of-Way

### (Curb Ramps)

| Intersection ID: N/A | Main Street: SUTHER_RD | Cross Street: SANDBURG_AV | Location: N |

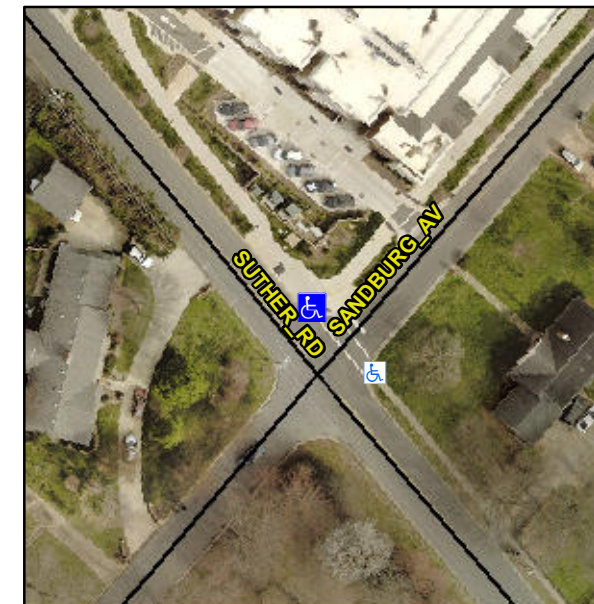
| ADA ID: 1C833B47E10F | Ramp Type: PerpDiag | Initial Pass/Fail: Pass | Overall Compliance: No |

| Compliance | Description | Data | Compliance | Description | Data |
|---|---|---|---|---|---|
| Yes | Ramp Width (in) | 48.0 | No | Ramp XSlope (%) | 4.0 |
| No | Landing X Slope (%) | 3.2 | Yes | DWS Full Width? | Yes |
| N/A | Landing Curb? (Y/N) | No | No | DWS Offset (in) | 3.0 |
| Yes | Gutter Lip Ht (in) | 0.0 | No | Gutter X Slope (%) | 4.0 |

**Remove & Replace Curb Ramp With Two New Directional Ramps or Equivalent. Remove & Replace Gutter.**

**R304.5.3, R305.2**

Total Cost: \$ 3950.00

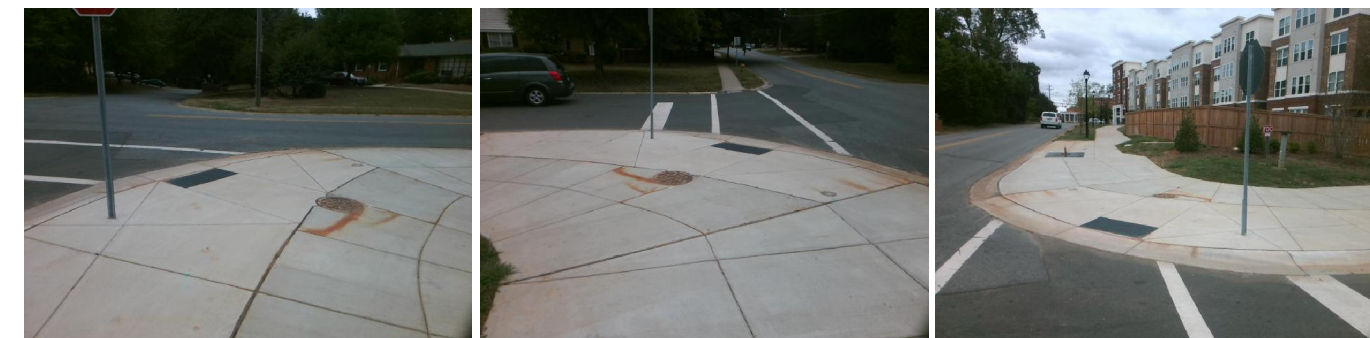
Street 1 Name SUTHER RD  
 Stop Condition-Street 2 None  
 Street 2 Name SANDBURG AV  
 Stop Condition-Street 1 StopSign
