Access Compliance Report Public Rights-of-Way (Curb Ramps)

Intersection ID: 54465 Main Street: RUPELL DR **Cross Street: COLLINGHAM DR** Location: NE ADA ID: 1C83D84A1869 Ramp Type: BlendTrans1 Initial Pass/Fail: Fail **Overall Compliance: No Severity Score:** 8.75

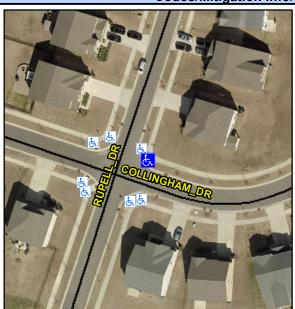
| Comp | liance Description | Data | Comp | liance Description | |
|---|---|---|---|---|--|
| No | Ramp Width (in) | 46.0 | Yes | BlendTrans XSlope (%) | |

Street 1 Name **COLLINGHAM DR** Stop Condition-Street 1 None Street 2 Name N/A Stop Condition-Street 2 N/A Possible Solutions: Remove & Replace Curb Ramp With Two New Directional Ramps or Equivalent. Surveyor Notes: N/A PROW/ADA: R304.5.1
