# Access Compliance Report

## Public Rights-of-Way

### (Curb Ramps)

Intersection ID: 42795	Main Street: PLUMLEAF_DR	Cross Street: RED_VULCAN_CT	Location: SE
ADA ID: 1C90F3BF7ADF	Ramp Type: PerpDiag	Initial Pass/Fail: Fail	Overall Compliance: No
			Severity Score: 13.75

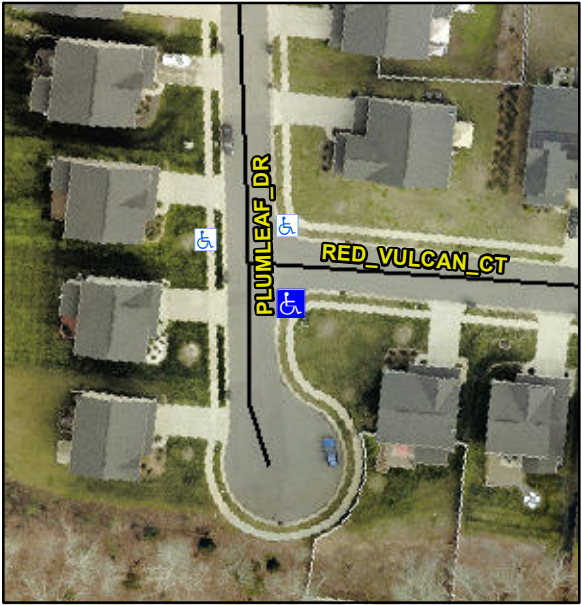
Possible Solutions:		<b>Compliance</b>	<b>Description</b>	<b>Data</b>
	<b>Remove &amp; Replace Curb Ramp With Two New Directional Ramps or Equivalent.</b>		<b>No</b>	Ramp Length (in)	47.0
			<b>Yes</b>	Ramp Width (in)	48.0
			<b>N/A</b>	Flare Type LT	N/A
			<b>N/A</b>	Flare Slope LT (%)	N/A
			<b>N/A</b>	Flare Traversable LT?	N/A
			<b>N/A</b>	Landing Length (in)	N/A
			<b>N/A</b>	Landing Width (in)	N/A
			<b>N/A</b>	Landing Slope (%)	N/A
			<b>N/A</b>	Landing X Slope (%)	N/A
			<b>N/A</b>	Landing Curb? (Y/N)	N/A
			<b>N/A</b>	Shared Landing?	N/A
			<b>N/A</b>	Gutter Ponding?	N/A
			<b>N/A</b>	Gutter Lip Ht (in)	N/A
			<b>No</b>	Painted X Walk1?	N/A
				X Walk 1 Direction	To N
			<b>N/A</b>	X Walk 1 Width (in)	N/A
				X Walk 1 Slope (%)	0.3
				X Walk 1 X Slope (%)	4.7
			<b>N/A</b>	Ramp inside XWalk1?	N/A
<p>Surveyor Notes:</p> <p><b>N/A</b></p> <p>PROW/ADA:</p> <p><b>Not Found, R304.2.2, R304.5.3</b></p>			<b>N/A</b>	Flare Type RT	N/A

<b>N/A</b>	Flare Slope RT (%)	N/A
			<b>N/A</b>	Flare Traversable RT?	N/A
			<b>N/A</b>	DWS Provided?	N/A
			<b>N/A</b>	DWS Contrast?	N/A
			<b>N/A</b>	DWS Length (in)	N/A
			<b>N/A</b>	DWS Full Width?	N/A
			<b>N/A</b>	DWS Offset (in)	N/A
			<b>N/A</b>	Gutter Slope (%)	N/A
			<b>N/A</b>	Gutter X Slope (%)	N/A
			<b>No</b>	Painted X Walk2?	N/A
				X Walk 2 Direction	To W
			<b>N/A</b>	X Walk 2 Width (in)	N/A
				X Walk 2 Slope (%)	1.3
				X Walk 2 X Slope (%)	1.5
			<b>N/A</b>	Ramp inside XWalk2?	N/A
			<b>N/A</b>	Clear Space?	N/A
			<b>N/A</b>	Clear Space to XWalk (in)	N/A
			<b>N/A</b>	Storm Grate/Utility Hazard?	N/A
				Storm Grate/Utility Type	
<p>Total Cost:</p> <p><b>\$ 3200.00</b></p>			<b>N/A</b>		<b>N/A</b>
			<b>Yes</b>	Surface Condition? (G/P)	<b>Good</b>
