Access Compliance Report

Public Rights-of-Way

(Curb Ramps)

Intersection ID: 12358	Main Street: HARRILL_ST	Cross Street: VAN_EVERY_ST	Location: E
ADA ID: 1CA24AC949E6	Ramp Type: PerpDiag	Initial Pass/Fail: Fail	Overall Compliance: No
Severity Score: 22.5			
Codes/Mitigation Info/Possible Solution		Field Measurements/Component Compliance

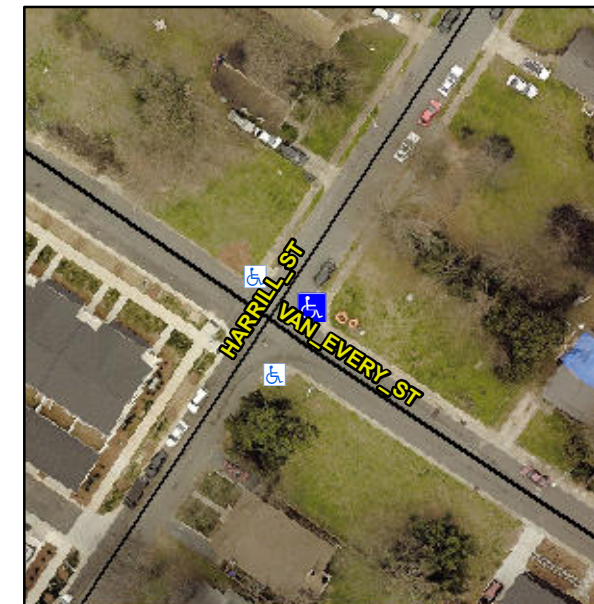
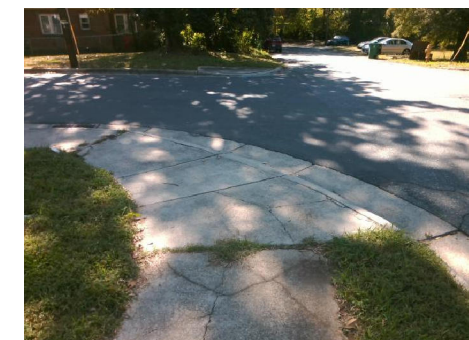
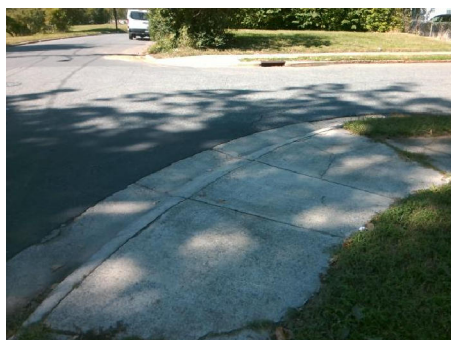
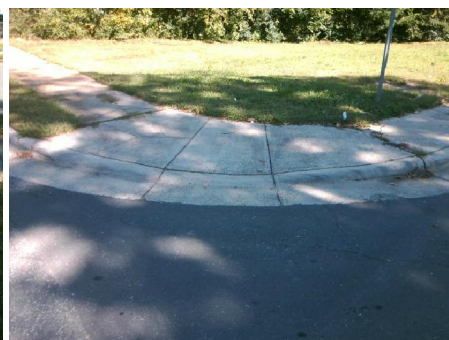
Not Found, R304.5.1, R304.2.2, R304.5.3

Compliance	Description	Data	Compliance	Description	Data
N/A	Ramp Length (in)	66.0	No	Ramp Slope (%)	8.5
No	Ramp Width (in)	36.0	No	Ramp XSlope (%)	2.6
N/A	Flare Type LT	N/A	N/A	Flare Type RT	N/A
N/A	Flare Slope LT (%)	N/A	N/A	Flare Slope RT (%)	N/A
N/A	Flare Traversable LT?	N/A	N/A	Flare Traversable RT?	N/A
N/A	Landing Length (in)	N/A	N/A	DWS Provided?	N/A
N/A	Landing Width (in)	N/A	N/A	DWS Contrast?	N/A
N/A	Landing Slope (%)	N/A	N/A	DWS Length (in)	N/A
N/A	Landing X Slope (%)	N/A	N/A	DWS Full Width?	N/A
N/A	Landing Curb? (Y/N)	N/A	N/A	DWS Offset (in)	N/A
N/A	Shared Landing?	N/A			
N/A	Gutter Ponding?	N/A	N/A	Gutter Slope (%)	N/A
N/A	Gutter Lip Ht (in)	N/A	N/A	Gutter X Slope (%)	N/A
N/A	Painted X Walk1?	No	N/A	Painted X Walk2?	No
	X Walk 1 Direction	To NW		X Walk 2 Direction	To SW
N/A	X Walk 1 Width (in)	N/A	N/A	X Walk 2 Width (in)	N/A
	X Walk 1 Slope (%)	3.4		X Walk 2 Slope (%)	0.6
	X Walk 1 X Slope (%)	2.3		X Walk 2 X Slope (%)	1.4

N/A	Ramp inside XWalk1?	N/A	N/A	Ramp inside XWalk2?	N/A
	Road Slope (%)	2.0	N/A	Clear Space?	N/A
	Road X Slope (%)	0.7	N/A	Clear Space to XWalk (in)	N/A
N/A	Any Obstructions?	N/A	N/A	Storm Grate/Utility Hazard?	N/A
	Obstruction Type			Storm Grate/Utility Type	
		N/A			N/A
			Yes	Surface Condition? (G/P)	Good

Remove & Replace Curb Ramp With Two New Directional Ramps or Equivalent.
