Access Compliance Report Public Rights-of-Way (Curb Ramps)

Intersection ID: 12428 Main Street: E_7TH_ST Cross Street: N_CALDWELL_ST Location: N

ADA ID: 1CA4D2B6103D Ramp Type: PerpDiag Initial Pass/Fail: Fail Overall Compliance: No Severity Score: 21.25

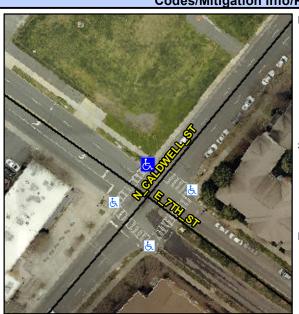
Compliance Description		Data	Compliance Description		Data
N/A	Ramp Length (in)	62.0	Yes	Ramp Slope (%)	5.1
No	Ramp Width (in)	47.0	No	Ramp XSlope (%)	5.6
N/A	Flare Type LT	N/A	N/A	Flare Type RT	N/A
N/A	Flare Slope LT (%)	N/A	N/A	Flare Slope RT (%)	N/A
N/A	Flare Traversable LT?	N/A	N/A	Flare Traversable RT?	N/A
N/A	Landing Length (in)	N/A	N/A	DWS Provided?	N/A
N/A	Landing Width (in)	N/A	N/A	DWS Contrast?	N/A
N/A	Landing Slope (%)	N/A	N/A	DWS Length (in)	N/A
N/A	Landing X Slope (%)	N/A	N/A	DWS Full Width?	N/A
N/A	Landing Curb? (Y/N)	N/A	N/A	DWS Offset (in)	N/A
N/A	Shared Landing?	N/A			
N/A	Gutter Ponding?	N/A	N/A	Gutter Slope (%)	N/A
N/A	Gutter Lip Ht (in)	N/A	N/A	Gutter X Slope (%)	N/A
N/A	Painted X Walk1?	Yes	N/A	Painted X Walk2?	Yes
	X Walk 1 Direction	To SW		X Walk 2 Direction	To SE
N/A	X Walk 1 Width (in)	80.0	N/A	X Walk 2 Width (in)	130.0
	X Walk 1 Slope (%)	0.0		X Walk 2 Slope (%)	0.1
	X Walk 1 X Slope (%)	1.8		X Walk 2 X Slope (%)	2.3

N/A	Ramp inside XWalk1?	Yes	N/A	Ramp inside XWalk2?	Yes
	Road Slope (%)	2.4	N/A	Clear Space?	N/A
	Road X Slope (%)	0.8	N/A	Clear Space to XWalk (in)	N/A

Remove & Replace Curb Ramp With
Two New Directional Ramps or
Equivalent.

PROW/ADA:
R304.5.1, R304.5.3
