# Access Compliance Report

## Public Rights-of-Way

| Intersection ID: 14867 | Main Street: CIRCLE_AV | Cross Street: WILLOUGHBY_ST | Location: SE |
| ADA ID: 1CAB88E2EF17 | Ramp Type: Directional1 | Initial Pass/Fail: Fail | Overall Compliance: No |

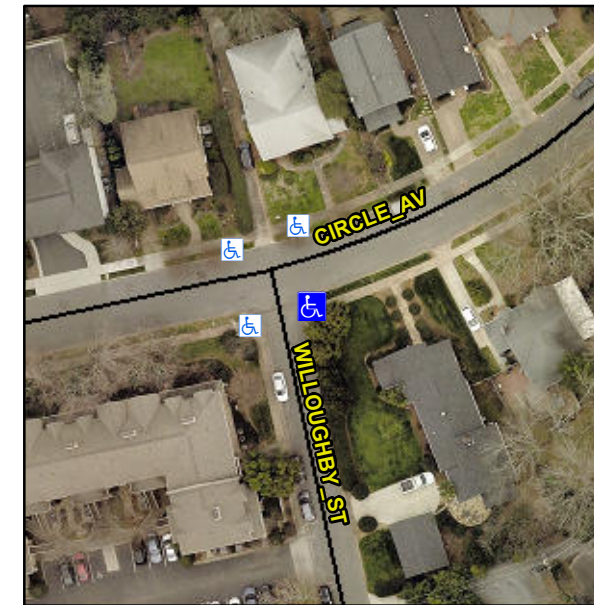
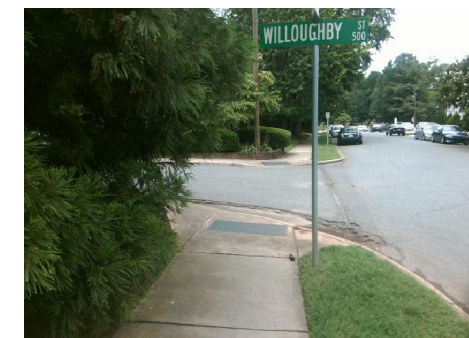
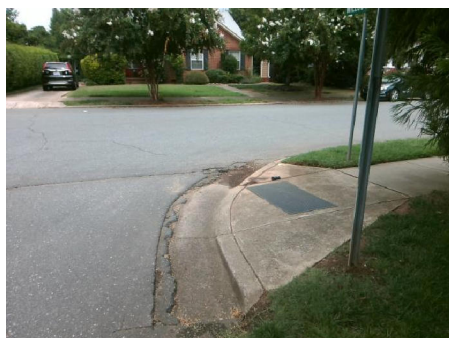
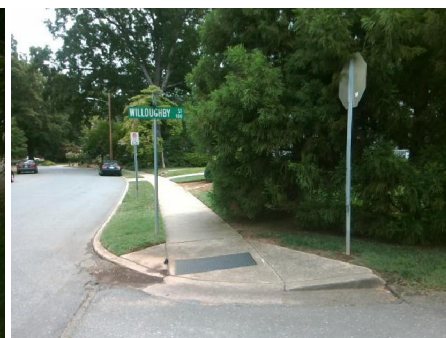
| | | Severity Score: 25 | |

**ASP LIP 1.5", CURB LIP 1.0"**

| Compliance | Description | Data | Compliance | Description | Data |
|---|---|---|---|---|---|
| No | Ramp XSlope (%) | 8.4 | | | |

**Remove & Replace Entire Ramp.**

**R304.5.3**
