## Access Compliance Report Public Rights-of-Way (Curb Ramps)

Intersection ID: 3448 Main Street: W\_W\_T\_HARRIS\_BV\_TO\_I-77\_RAOSBBStreet: I-77\_TO\_W\_W\_T\_HARRIS\_BV\_RA\_SB Location: SE

ADA ID: 1CB771A7ED9C Ramp Type: Perp Initial Pass/Fail: Fail Overall Compliance: No Severity Score: 12.5

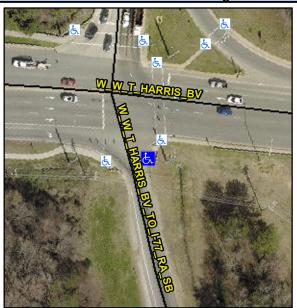
on obsidic oblation	ricia measarements/component compnance							
Possible Solutions:		Compl	Compliance Description D			Compliance Description		
Remove & Replace Entire F	Ramp.	N/A	Ramp Length (in)	90.5	No	Ramp Slope (%)		
·	•	Yes	Ramp Width (in)	48.0	Yes	Ramp XSlope (%)		
		N/A	Flare Type LT	N/A	N/A	Flare Type RT		
		N/A	Flare Slope LT (%)	N/A	N/A	Flare Slope RT (%)		
		N/A	Flare Traversable LT?	N/A	N/A	Flare Traversable RT?		
		N/A	Landing Length (in)	N/A	N/A	DWS Provided?		
Surveyor Notes:		N/A	Landing Width (in)	N/A	N/A	DWS Contrast?		
N/A		N/A	Landing Slope (%)	N/A	N/A	DWS Length (in)		
		N/A	Landing X Slope (%)	N/A	N/A	DWS Full Width?		
		N/A	Landing Curb? (Y/N)	N/A	N/A	DWS Offset (in)		
		N/A	Shared Landing?	N/A				
PROW/ADA:		N/A	Gutter Ponding?	N/A	N/A	Gutter Slope (%)		
Not Found, R304.2.2		N/A	Gutter Lip Ht (in)	N/A	N/A	Gutter X Slope (%)		
		N/A	Painted X Walk1?	Yes	N/A	Painted X Walk2?		
<b>V</b>			X Walk 1 Direction	To W		X Walk 2 Direction

N/A	X Walk 1 Width (in)	106.0	N/A	X Walk 2 Width (in)		
			X Walk 1 Slope (%)	0.8		X Walk 2 Slope (%)		
			X Walk 1 X Slope (%)	1.5		X Walk 2 X Slope (%)		
		N/A	Ramp inside XWalk1?	Yes	N/A	Ramp inside XWalk2?		
			Road Slope (%)	N/A	N/A	Clear Space?		
			Road X Slope (%)	N/A	N/A	Clear Space to XWalk (in)		
		N/A	Any Obstructions?	N/A	N/A	Storm Grate/Utility Hazard?		
Total Cost:	\$ 1850.00		Obstruction Type			Storm Grate/Utility Type
