Access Compliance Report

Public Rights-of-Way

(Curb Ramps)

| Intersection ID: 27728 | Main Street: BALLANTYNE_COUNTRY_CLUB_DR | Cross Street: COYLE_CR | Location: SW |

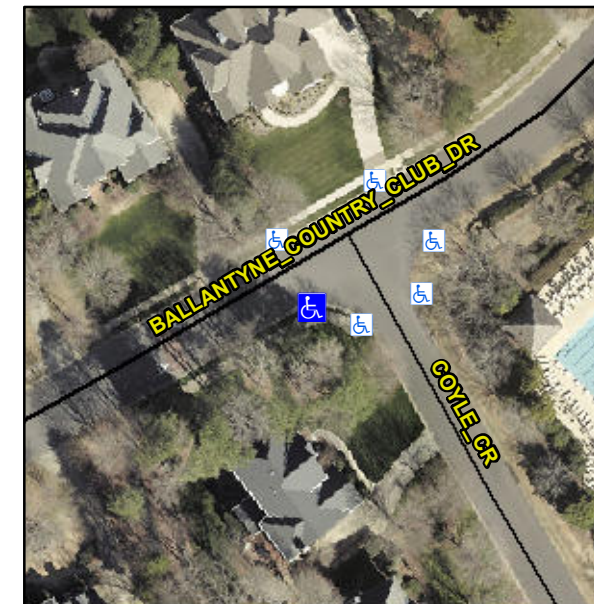
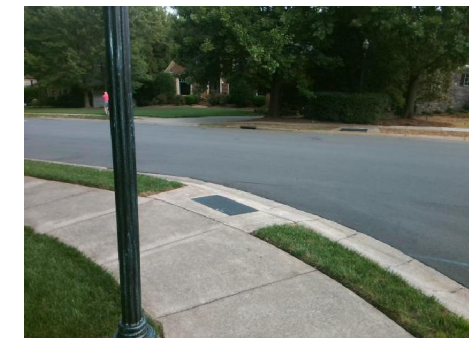
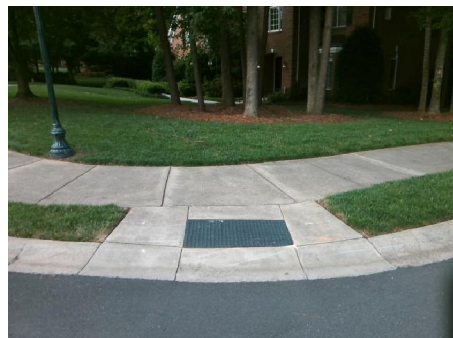
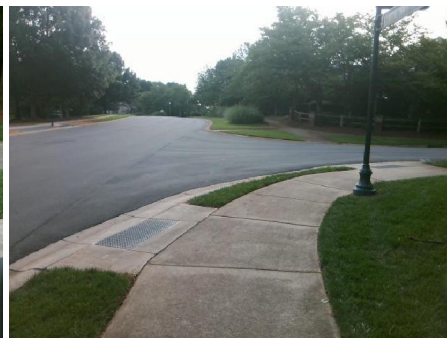
| ADA ID: 1CC36B473AA7 | Ramp Type: Perp | Initial Pass/Fail: Fail | Overall Compliance: No |

Not Found, R304.2.2, R304.5.3

| Compliance | Description | Data | Compliance | Description | Data |
|---|---|---|---|---|---|
| N/A | Ramp Length (in) | 38.0 | No | Ramp Slope (%) | 8.7 |
| Yes | Ramp Width (in) | 48.0 | No | Ramp XSlope (%) | 5.5 |

Possible Solutions:

Remove & Replace Entire Ramp.
