Access Compliance Report Public Rights-of-Way (Curb Ramps)

Intersection ID: 27494 Main Street: BALLANTYNE_COMMONS_PY Cross Street: SUMMIT_COMMONS_BV Location: NW
ADA ID: 1CC86B45A600 Ramp Type: Perp Initial Pass/Fail: Fail Overall Compliance: No Severity Score: 10

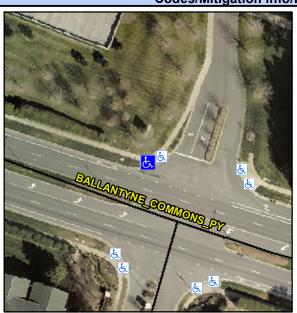
Not Found, R304.5.1

Compliance Description Data		Compliance Description		Data		
N/A	Ramp Length (in)	132.5	Yes	Ramı	Slope (%)	6.9
No	Ramp Width (in)	40.5	Yes	Ram	XSlope (%)	2.7
N/A	Flare Type LT	N/A	N/A	Flare	Type RT	N/A
N/A	Flare Slope LT (%)	N/A	N/A	Flare	Slope RT (%)	N/A
N/A	Flare Traversable LT?	N/A	N/A	Flare	Traversable RT?	N/A
N/A	Landing Length (in)	N/A	N/A	DWS	Provided?	N/A
N/A	Landing Width (in)	N/A	N/A	DWS	Contrast?	N/A
N/A	Landing Slope (%)	N/A	N/A	DWS	Length (in)	N/A
N/A	Landing X Slope (%)	N/A	N/A	DWS	Full Width?	N/A
N/A	Landing Curb? (Y/N)	N/A	N/A	DWS	Offset (in)	N/A
N/A	Shared Landing?	N/A				
N/A	Gutter Ponding?	N/A	N/A	Gutte	er Slope (%)	N/A
N/A	Gutter Lip Ht (in)	N/A	N/A	Gutte	er X Slope (%)	N/A
N/A	Painted X Walk1?	No	N/A	Paint	ed X Walk2?	N/A
	X Walk 1 Direction	To SW		X Wa	lk 2 Direction	N/A
N/A	X Walk 1 Width (in)	N/A	N/A	X Wa	lk 2 Width (in)	N/A
	X Walk 1 Slope (%)	0.2		X Wa	lk 2 Slope (%)	N/A
	X Walk 1 X Slope (%)	5.8		X Wa	lk 2 X Slope (%)	N/A

Remove & Replace Entire Ramp.
