Access Compliance Report

Public Rights-of-Way

(Curb Ramps)

Intersection ID: 24081	Main Street: PRESCOTT_POND_LN	Cross Street: SHARPTHORNE_PL	Location: NW
ADA ID: 1CCDB00D3BB7	Ramp Type: PerpDiag	Initial Pass/Fail: Fail	Overall Compliance: No
Severity Score: 8.75			
Codes/Mitigation Info/Possible Solution		Field Measurements/Component Compliance

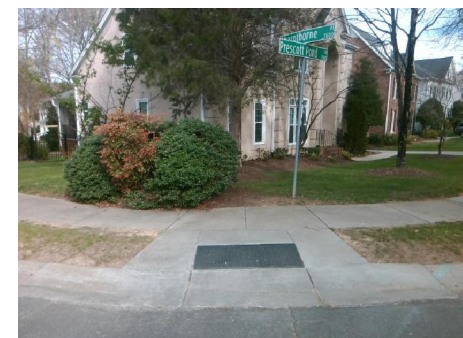
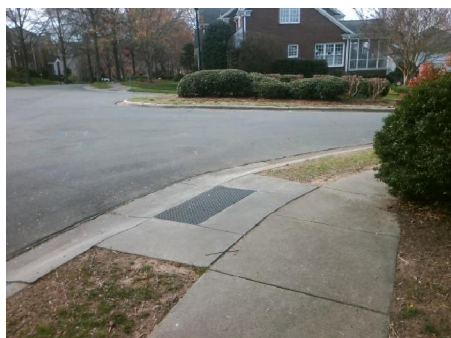
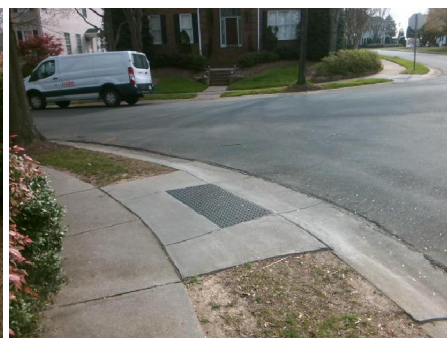
Compliance	Description	Data	Compliance	Description	Data
N/A	Ramp Length (in)	47.0	Yes	Ramp Slope (%)	5.5
No	Ramp Width (in)	47.0	Yes	Ramp XSlope (%)	0.1
N/A	Flare Type LT	N/A	N/A	Flare Type RT	N/A
N/A	Flare Slope LT (%)	N/A	N/A	Flare Slope RT (%)	N/A
N/A	Flare Traversable LT?	N/A	N/A	Flare Traversable RT?	N/A
N/A	Landing Length (in)	N/A	N/A	DWS Provided?	N/A
N/A	Landing Width (in)	N/A	N/A	DWS Contrast?	N/A
N/A	Landing Slope (%)	N/A	N/A	DWS Length (in)	N/A
N/A	Landing X Slope (%)	N/A	N/A	DWS Full Width?	N/A
N/A	Landing Curb? (Y/N)	N/A	N/A	DWS Offset (in)	N/A
N/A	Shared Landing?	N/A			
N/A	Gutter Ponding?	N/A	N/A	Gutter Slope (%)	N/A
N/A	Gutter Lip Ht (in)	N/A	N/A	Gutter X Slope (%)	N/A
N/A	Painted X Walk1?	No	N/A	Painted X Walk2?	No
	X Walk 1 Direction	To S		X Walk 2 Direction	To E
N/A	X Walk 1 Width (in)	N/A	N/A	X Walk 2 Width (in)	N/A
	X Walk 1 Slope (%)	5.2		X Walk 2 Slope (%)	2.3
	X Walk 1 X Slope (%)	3.2		X Walk 2 X Slope (%)	1.6

N/A	Ramp inside XWalk1?	N/A	N/A	Ramp inside XWalk2?	N/A
	Road Slope (%)	1.0	N/A	Clear Space?	N/A
	Road X Slope (%)	3.9	N/A	Clear Space to XWalk (in)	N/A
N/A	Any Obstructions?	N/A	N/A	Storm Grate/Utility Hazard?	N/A
	Obstruction Type			Storm Grate/Utility Type	
		N/A			N/A
			Yes	Surface Condition? (G/P)	Good

Remove & Replace Curb Ramp With Two New Directional Ramps or Equivalent.
