# Access Compliance Report

## Public Rights-of-Way

### (Curb Ramps)

Intersection ID: 13568	Main Street: ARLINGTON_AV	Cross Street: SOUTH_BV	Location: S
ADA ID: 1CDC40520B6D	Ramp Type: PerpDiag	Initial Pass/Fail: Fail	Overall Compliance: No
		Severity Score: 25

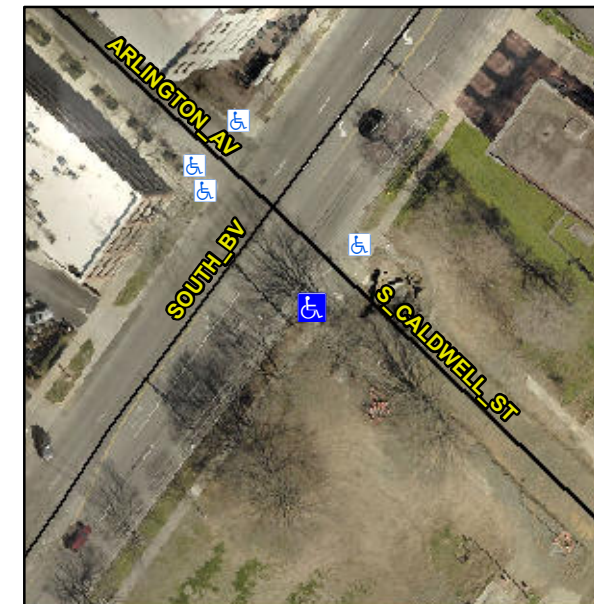
**Not Found, R304.5.3**

Compliance	Description	Data	Compliance	Description	Data
N/A	Ramp Length (in)	48.0	Yes	Ramp Slope (%)	5.6
Yes	Ramp Width (in)	48.0	No	Ramp XSlope (%)	8.1
N/A	Flare Type LT	N/A	N/A	Flare Type RT	N/A
N/A	Flare Slope LT (%)	N/A	N/A	Flare Slope RT (%)	N/A
N/A	Flare Traversable LT?	N/A	N/A	Flare Traversable RT?	N/A
N/A	Landing Length (in)	N/A	N/A	DWS Provided?	N/A
N/A	Landing Width (in)	N/A	N/A	DWS Contrast?	N/A
N/A	Landing Slope (%)	N/A	N/A	DWS Length (in)	N/A
N/A	Landing X Slope (%)	N/A	N/A	DWS Full Width?	N/A
N/A	Landing Curb? (Y/N)	N/A	N/A	DWS Offset (in)	N/A
N/A	Shared Landing?	N/A			
N/A	Gutter Ponding?	N/A	N/A	Gutter Slope (%)	N/A
N/A	Gutter Lip Ht (in)	N/A	N/A	Gutter X Slope (%)	N/A
N/A	Painted X Walk1?	Yes	N/A	Painted X Walk2?	No
	X Walk 1 Direction	To NE		X Walk 2 Direction	To NW
N/A	X Walk 1 Width (in)	118.0	N/A	X Walk 2 Width (in)	N/A
	X Walk 1 Slope (%)	0.1		X Walk 2 Slope (%)	5.8
	X Walk 1 X Slope (%)	7.0		X Walk 2 X Slope (%)	0.7

N/A	Ramp inside XWalk1?	Yes	N/A	Ramp inside XWalk2?	N/A
	Road Slope (%)	3.3	N/A	Clear Space?	N/A
	Road X Slope (%)	5.2	N/A	Clear Space to XWalk (in)	N/A
N/A	Any Obstructions?	N/A	N/A	Storm Grate/Utility Hazard?	N/A
	Obstruction Type			Storm Grate/Utility Type	
		N/A			N/A
		Yes		Surface Condition? (G/P)	Good

**Remove & Replace Curb Ramp With Two New Directional Ramps or Equivalent.**

Total Cost: \$ 3200.00
