Access Compliance Report

Public Rights-of-Way

(Curb Ramps)

Intersection ID: 25538	Main Street: HATTON_CROSS_DR	Cross Street: KENSAL_GREEN_DR	Location: SE
ADA ID: 1CE42679692A	Ramp Type: PerpDiag	Initial Pass/Fail: Fail	Overall Compliance: No
		Severity Score: 35

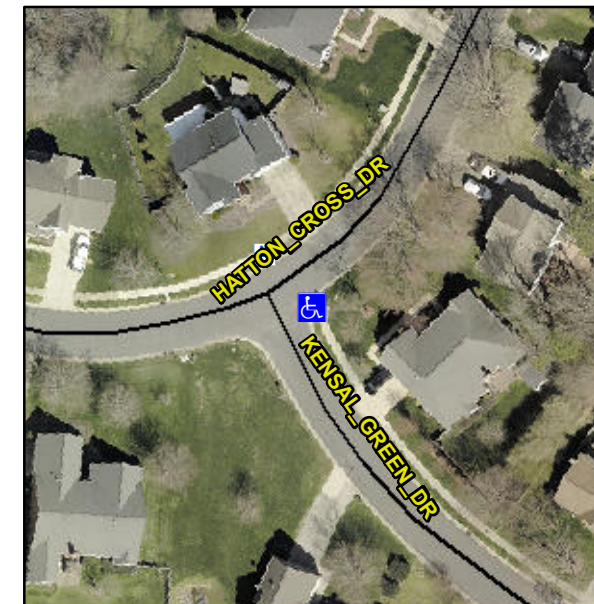
Not Found, R304.5.1

Compliance	Description	Data	Compliance	Description	Data
N/A	Ramp Length (in)	97.0	Yes	Ramp Slope (%)	5.7
No	Ramp Width (in)	28.3	Yes	Ramp XSlope (%)	0.9
N/A	Flare Type LT	N/A	N/A	Flare Type RT	N/A
N/A	Flare Slope LT (%)	N/A	N/A	Flare Slope RT (%)	N/A
N/A	Flare Traversable LT?	N/A	N/A	Flare Traversable RT?	N/A
N/A	Landing Length (in)	N/A	N/A	DWS Provided?	N/A
N/A	Landing Width (in)	N/A	N/A	DWS Contrast?	N/A
N/A	Landing Slope (%)	N/A	N/A	DWS Length (in)	N/A
N/A	Landing X Slope (%)	N/A	N/A	DWS Full Width?	N/A
N/A	Landing Curb? (Y/N)	N/A	N/A	DWS Offset (in)	N/A
N/A	Shared Landing?	N/A			
N/A	Gutter Ponding?	N/A	N/A	Gutter Slope (%)	N/A
N/A	Gutter Lip Ht (in)	N/A	N/A	Gutter X Slope (%)	N/A
N/A	Painted X Walk1?	No	N/A	Painted X Walk2?	No
	X Walk 1 Direction	To NW		X Walk 2 Direction	To SW
N/A	X Walk 1 Width (in)	N/A	N/A	X Walk 2 Width (in)	N/A
	X Walk 1 Slope (%)	1.2		X Walk 2 Slope (%)	1.0
	X Walk 1 X Slope (%)	0.5		X Walk 2 X Slope (%)	0.6

N/A	Ramp inside XWalk1?	N/A	N/A	Ramp inside XWalk2?	N/A
	Road Slope (%)	2.3	N/A	Clear Space?	N/A
	Road X Slope (%)	1.3	N/A	Clear Space to XWalk (in)	N/A
N/A	Any Obstructions?	N/A	N/A	Storm Grate/Utility Hazard?	N/A
	Obstruction Type			Storm Grate/Utility Type	
		N/A			N/A
			Yes	Surface Condition? (G/P)	Good

Remove & Replace Curb Ramp With Two New Directional Ramps or Equivalent.
