# Access Compliance Report

## Public Rights-of-Way

### (Curb Ramps)

Intersection ID: 10022634	Main Street: CARMEL_RD	Cross Street: N/A	Location: NE
ADA ID: 1CEBB04F9BA2	Ramp Type: PerpDiag	Initial Pass/Fail: Fail	Overall Compliance: No
		Severity Score: 12.5

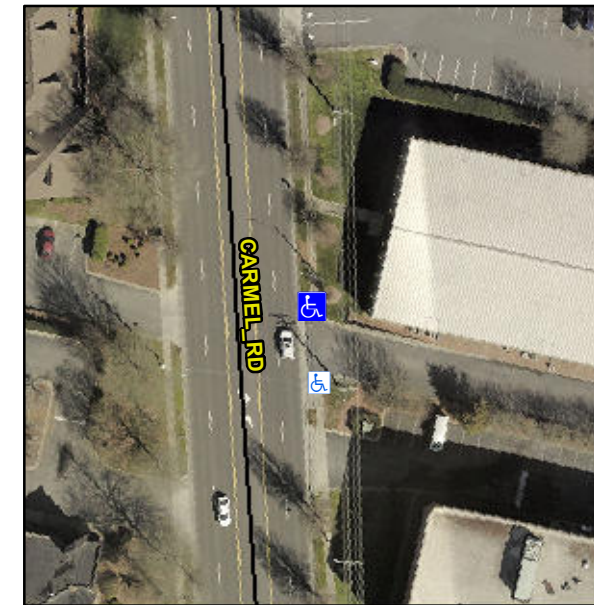
**Not Found, R304.2.2**

Compliance	Description	Data	Compliance	Description	Data
N/A	Ramp Length (in)	73.0	No	Ramp Slope (%)	9.6
Yes	Ramp Width (in)	48.0	Yes	Ramp XSlope (%)	0.9
N/A	Flare Type LT	N/A	N/A	Flare Type RT	N/A
N/A	Flare Slope LT (%)	N/A	N/A	Flare Slope RT (%)	N/A
N/A	Flare Traversable LT?	N/A	N/A	Flare Traversable RT?	N/A
N/A	Landing Length (in)	N/A	N/A	DWS Provided?	N/A
N/A	Landing Width (in)	N/A	N/A	DWS Contrast?	N/A
N/A	Landing Slope (%)	N/A	N/A	DWS Length (in)	N/A
N/A	Landing X Slope (%)	N/A	N/A	DWS Full Width?	N/A
N/A	Landing Curb? (Y/N)	N/A	N/A	DWS Offset (in)	N/A
N/A	Shared Landing?	N/A			
N/A	Gutter Ponding?	N/A	N/A	Gutter Slope (%)	N/A
N/A	Gutter Lip Ht (in)	N/A	N/A	Gutter X Slope (%)	N/A
N/A	Painted X Walk1?	No	N/A	Painted X Walk2?	No
	X Walk 1 Direction	To W		X Walk 2 Direction	To S
N/A	X Walk 1 Width (in)	N/A	N/A	X Walk 2 Width (in)	N/A
	X Walk 1 Slope (%)	2.6		X Walk 2 Slope (%)	2.6
	X Walk 1 X Slope (%)	0.6		X Walk 2 X Slope (%)	0.8

N/A	Ramp inside XWalk1?	N/A	N/A	Ramp inside XWalk2?	N/A
	Road Slope (%)	1.3	N/A	Clear Space?	N/A
	Road X Slope (%)	2.2	N/A	Clear Space to XWalk (in)	N/A
N/A	Any Obstructions?	N/A	N/A	Storm Grate/Utility Hazard?	N/A
	Obstruction Type			Storm Grate/Utility Type	
		N/A			N/A
		Yes		Surface Condition? (G/P)	Good

**Remove & Replace Curb Ramp With Two New Directional Ramps or Equivalent.**
