Access Compliance Report

Public Rights-of-Way

(Curb Ramps)

Intersection ID: 29758	Main Street: BALLANTYNE_COMMONS_PY	Cross Street: WILLIAMS_POND_LN	Location: SW
ADA ID: 1CF26D7826BB	Ramp Type: Perp	Initial Pass/Fail: Fail	Overall Compliance: No
Severity Score: 22.5			
Codes/Mitigation Info/Possible Solution		Field Measurements/Component Compliance

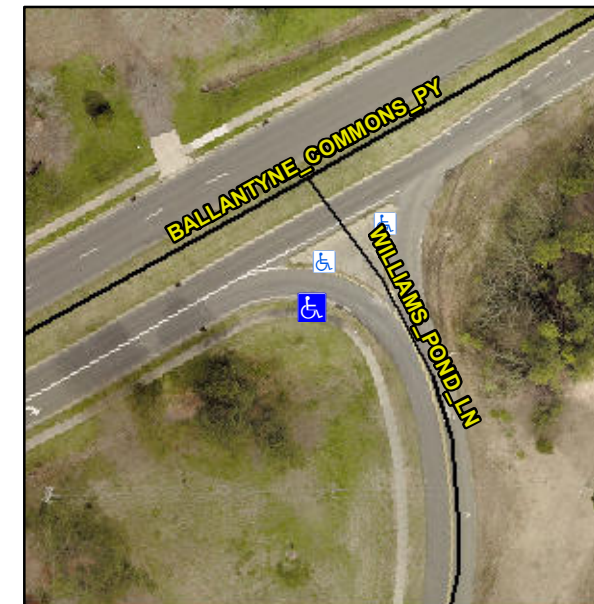
Not Found, R304.5.1, R304.2.2, R304.5.3

Compliance	Description	Data	Compliance	Description	Data
N/A	Ramp Length (in)	109.0	No	Ramp Slope (%)	8.8
No	Ramp Width (in)	41.5	No	Ramp XSlope (%)	4.7
N/A	Flare Type LT	N/A	N/A	Flare Type RT	N/A
N/A	Flare Slope LT (%)	N/A	N/A	Flare Slope RT (%)	N/A
N/A	Flare Traversable LT?	N/A	N/A	Flare Traversable RT?	N/A
N/A	Landing Length (in)	N/A	N/A	DWS Provided?	N/A
N/A	Landing Width (in)	N/A	N/A	DWS Contrast?	N/A
N/A	Landing Slope (%)	N/A	N/A	DWS Length (in)	N/A
N/A	Landing X Slope (%)	N/A	N/A	DWS Full Width?	N/A
N/A	Landing Curb? (Y/N)	N/A	N/A	DWS Offset (in)	N/A
N/A	Shared Landing?	N/A			
N/A	Gutter Ponding?	N/A	N/A	Gutter Slope (%)	N/A
N/A	Gutter Lip Ht (in)	N/A	N/A	Gutter X Slope (%)	N/A
N/A	Painted X Walk1?	No	N/A	Painted X Walk2?	N/A
	X Walk 1 Direction	To NE		X Walk 2 Direction	N/A
N/A	X Walk 1 Width (in)	N/A	N/A	X Walk 2 Width (in)	N/A
	X Walk 1 Slope (%)	0.8		X Walk 2 Slope (%)	N/A
	X Walk 1 X Slope (%)	2.8		X Walk 2 X Slope (%)	N/A

N/A	Ramp inside XWalk1?	N/A	N/A	Ramp inside XWalk2?	N/A
	Road Slope (%)	N/A	N/A	Clear Space?	N/A
	Road X Slope (%)	N/A	N/A	Clear Space to XWalk (in)	N/A
N/A	Any Obstructions?	N/A	N/A	Storm Grate/Utility Hazard?	N/A
	Obstruction Type			Storm Grate/Utility Type	
		N/A			N/A
			Yes	Surface Condition? (G/P)	Good

Possible Solutions:

Remove & Replace Entire Ramp.
