Access Compliance Report

Public Rights-of-Way

(Curb Ramps)

Intersection ID: 15351	Main Street: BARRINGER_DR	Cross Street: CLANTON_RD	Location: NE
ADA ID: 1CF336A22FB0	Ramp Type: Perp	Initial Pass/Fail: Pass	Overall Compliance: No
Severity Score: 0			
Codes/Mitigation Info/Possible Solution		Field Measurements/Component Compliance

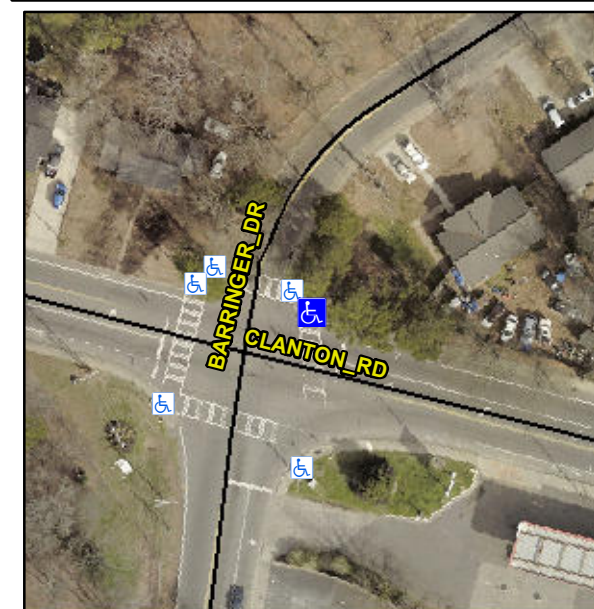
Compliance	Description	Data	Compliance	Description	Data
N/A	Ramp Length (in)	48.0	Yes	Ramp Slope (%)	7.4
Yes	Ramp Width (in)	48.0	Yes	Ramp XSlope (%)	1.8
N/A	Flare Type LT	Sloped	N/A	Flare Type RT	N/A
N/A	Flare Slope LT (%)	5.0	Yes	Flare Slope RT (%)	6.3
N/A	Flare Traversable LT?	Yes	N/A	Flare Traversable RT?	Yes
No	Landing Length (in)	24.0	Yes	DWS Provided?	Yes
Yes	Landing Width (in)	48.0	Yes	DWS Contrast?	Yes
No	Landing Slope (%)	2.4	Yes	DWS Length (in)	24.0
Yes	Landing X Slope (%)	1.4	Yes	DWS Full Width?	Yes
N/A	Landing Curb? (Y/N)	No	No	DWS Offset (in)	7.0
N/A	Shared Landing?	No			
Yes	Gutter Ponding?	No	Yes	Gutter Slope (%)	1.7
Yes	Gutter Lip Ht (in)	0.0	No	Gutter X Slope (%)	2.6
N/A	Painted X Walk1?	Yes	N/A	Painted X Walk2?	N/A
	X Walk 1 Direction	To S		X Walk 2 Direction	N/A
N/A	X Walk 1 Width (in)	108.0	N/A	X Walk 2 Width (in)	N/A
	X Walk 1 Slope (%)	6.0		X Walk 2 Slope (%)	N/A
	X Walk 1 X Slope (%)	1.1		X Walk 2 X Slope (%)	N/A

Yes	Ramp inside XWalk1?	Yes	N/A	Ramp inside XWalk2?	N/A
	Road Slope (%)	N/A	N/A	Clear Space?	Yes
	Road X Slope (%)	N/A	N/A	Clear Space to XWalk (in)	N/A
Yes	Any Obstructions?	No	Yes	Storm Grate/Utility Hazard?	No
	Obstruction Type			Storm Grate/Utility Type	
			N/A		N/A
			Yes	Surface Condition? (G/P)	Good

Possible Solutions:

**Remove & Replace Entire Ramp.
Remove & Replace Gutter.**
