Access Compliance Report

Public Rights-of-Way

(Curb Ramps)

Intersection ID: 44232	Main Street: PAPER_BIRCH_DR	Cross Street: MAIDENHAIR_CT	Location: SE
ADA ID: 1CF3EB1B683D	Ramp Type: Perp	Initial Pass/Fail: Fail	Overall Compliance: No
Severity Score: 12.5			
Codes/Mitigation Info/Possible Solution		Field Measurements/Component Compliance

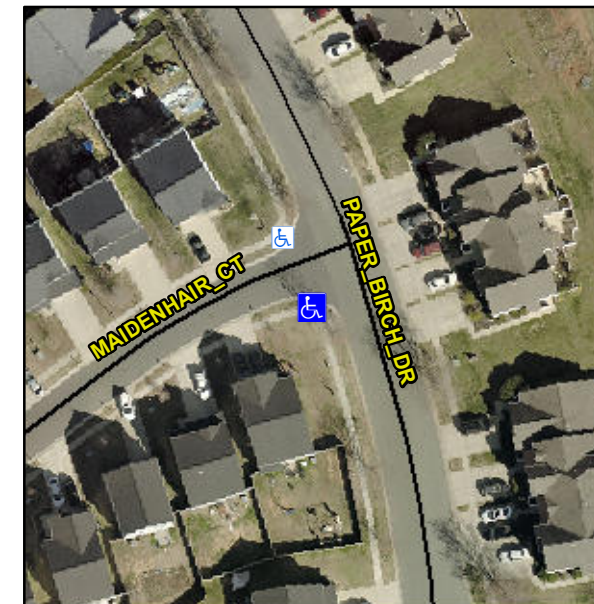
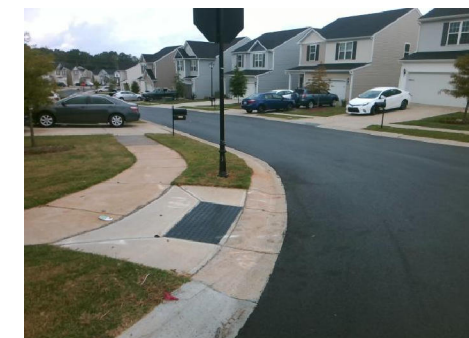
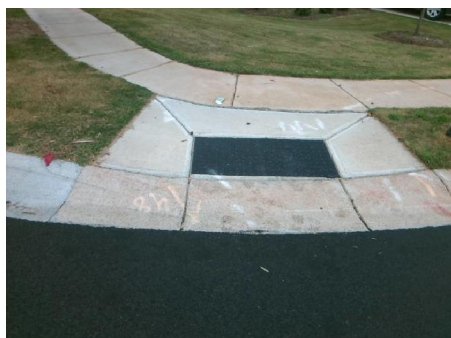
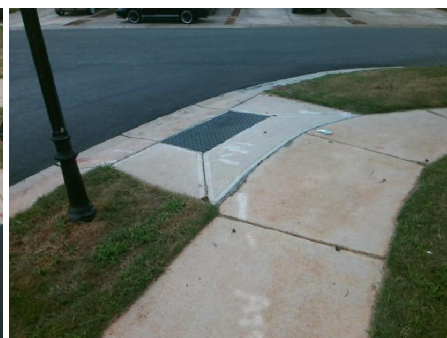
Not Found, R304.5.3

Compliance	Description	Data	Compliance	Description	Data
N/A	Ramp Length (in)	47.5	Yes	Ramp Slope (%)	7.2
Yes	Ramp Width (in)	48.0	No	Ramp XSlope (%)	5.4
N/A	Flare Type LT	N/A	N/A	Flare Type RT	N/A
N/A	Flare Slope LT (%)	N/A	N/A	Flare Slope RT (%)	N/A
N/A	Flare Traversable LT?	N/A	N/A	Flare Traversable RT?	N/A
N/A	Landing Length (in)	N/A	N/A	DWS Provided?	N/A
N/A	Landing Width (in)	N/A	N/A	DWS Contrast?	N/A
N/A	Landing Slope (%)	N/A	N/A	DWS Length (in)	N/A
N/A	Landing X Slope (%)	N/A	N/A	DWS Full Width?	N/A
N/A	Landing Curb? (Y/N)	N/A	N/A	DWS Offset (in)	N/A
N/A	Shared Landing?	N/A			
N/A	Gutter Ponding?	N/A	N/A	Gutter Slope (%)	N/A
N/A	Gutter Lip Ht (in)	N/A	N/A	Gutter X Slope (%)	N/A
N/A	Painted X Walk1?	No	N/A	Painted X Walk2?	N/A
	X Walk 1 Direction	To N		X Walk 2 Direction	N/A
N/A	X Walk 1 Width (in)	N/A	N/A	X Walk 2 Width (in)	N/A
	X Walk 1 Slope (%)	1.6		X Walk 2 Slope (%)	N/A
	X Walk 1 X Slope (%)	4.4		X Walk 2 X Slope (%)	N/A

N/A	Ramp inside XWalk1?	N/A	N/A	Ramp inside XWalk2?	N/A
	Road Slope (%)	N/A	N/A	Clear Space?	N/A
	Road X Slope (%)	N/A	N/A	Clear Space to XWalk (in)	N/A
N/A	Any Obstructions?	N/A	N/A	Storm Grate/Utility Hazard?	N/A
	Obstruction Type			Storm Grate/Utility Type	
		N/A			N/A
		Yes		Surface Condition? (G/P)	Good

Possible Solutions:

Remove & Replace Entire Ramp.

Total Cost: \$ 1850.00
