Access Compliance Report

Public Rights-of-Way

(Curb Ramps)

Intersection ID: 10662	Main Street: E_36TH_ST	Cross Street: HOLT_ST	Location: E
ADA ID: 1CF6C2517D5A	Ramp Type: PerpDiag	Initial Pass/Fail: Fail	Overall Compliance: No
		Severity Score: 8.75

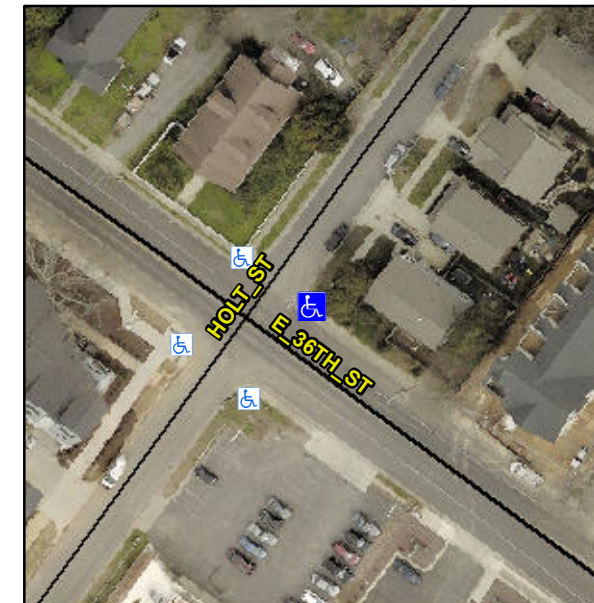
Not Found, R304.5.1

Compliance	Description	Data	Compliance	Description	Data
N/A	Ramp Length (in)	42.0	Yes	Ramp Slope (%)	7.1
No	Ramp Width (in)	47.5	Yes	Ramp XSlope (%)	0.6
N/A	Flare Type LT	N/A	N/A	Flare Type RT	N/A
N/A	Flare Slope LT (%)	N/A	N/A	Flare Slope RT (%)	N/A
N/A	Flare Traversable LT?	N/A	N/A	Flare Traversable RT?	N/A
N/A	Landing Length (in)	N/A	N/A	DWS Provided?	N/A
N/A	Landing Width (in)	N/A	N/A	DWS Contrast?	N/A
N/A	Landing Slope (%)	N/A	N/A	DWS Length (in)	N/A
N/A	Landing X Slope (%)	N/A	N/A	DWS Full Width?	N/A
N/A	Landing Curb? (Y/N)	N/A	N/A	DWS Offset (in)	N/A
N/A	Shared Landing?	N/A			
N/A	Gutter Ponding?	N/A	N/A	Gutter Slope (%)	N/A
N/A	Gutter Lip Ht (in)	N/A	N/A	Gutter X Slope (%)	N/A
N/A	Painted X Walk1?	No	N/A	Painted X Walk2?	No
	X Walk 1 Direction	To NW		X Walk 2 Direction	To SW
N/A	X Walk 1 Width (in)	N/A	N/A	X Walk 2 Width (in)	N/A
	X Walk 1 Slope (%)	1.6		X Walk 2 Slope (%)	1.6
	X Walk 1 X Slope (%)	0.9		X Walk 2 X Slope (%)	1.2

N/A	Ramp inside XWalk1?	N/A	N/A	Ramp inside XWalk2?	N/A
	Road Slope (%)	0.3	N/A	Clear Space?	N/A
	Road X Slope (%)	2.7	N/A	Clear Space to XWalk (in)	N/A
N/A	Any Obstructions?	N/A	N/A	Storm Grate/Utility Hazard?	N/A
	Obstruction Type			Storm Grate/Utility Type	
		N/A			N/A
			Yes	Surface Condition? (G/P)	Good

Remove & Replace Curb Ramp With Two New Directional Ramps or Equivalent.
