# Access Compliance Report

## Public Rights-of-Way

### (Curb Ramps)

Intersection ID: 6014	Main Street: RUMPLE_RD	Cross Street: RIDGE_LANE_RD	Location: SE
ADA ID: 1D018F523D87	Ramp Type: PerpDiag	Initial Pass/Fail: Fail	Overall Compliance: No
Severity Score: 8.75			
Codes/Mitigation Info/Possible Solution		Field Measurements/Component Compliance

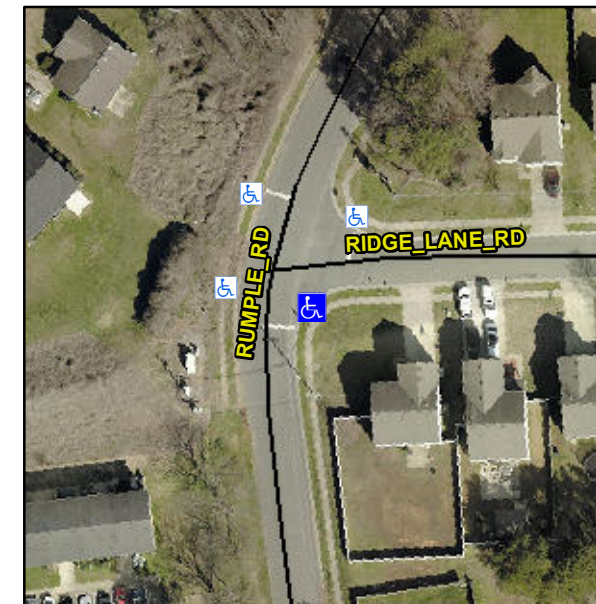
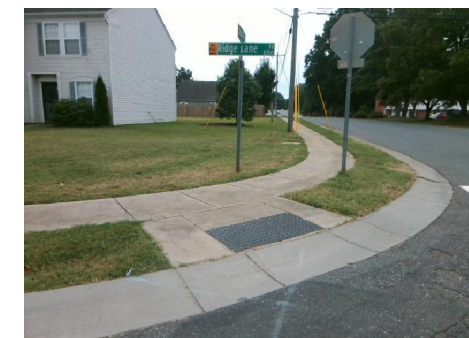
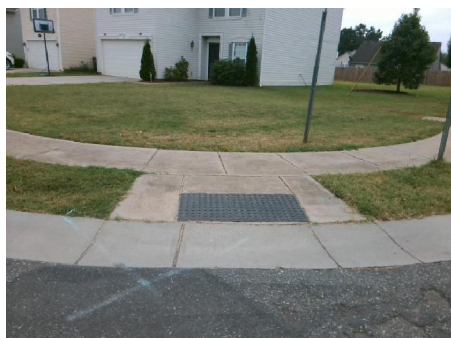
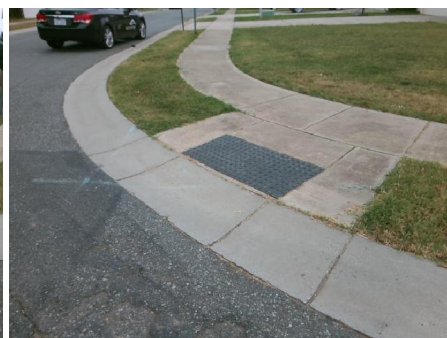
Compliance	Description	Data	Compliance	Description	Data
N/A	Ramp Length (in)	49.0	Yes	Ramp Slope (%)	5.8
No	Ramp Width (in)	46.5	Yes	Ramp XSlope (%)	1.6
N/A	Flare Type LT	N/A	N/A	Flare Type RT	N/A
N/A	Flare Slope LT (%)	N/A	N/A	Flare Slope RT (%)	N/A
N/A	Flare Traversable LT?	N/A	N/A	Flare Traversable RT?	N/A
N/A	Landing Length (in)	N/A	N/A	DWS Provided?	N/A
N/A	Landing Width (in)	N/A	N/A	DWS Contrast?	N/A
N/A	Landing Slope (%)	N/A	N/A	DWS Length (in)	N/A
N/A	Landing X Slope (%)	N/A	N/A	DWS Full Width?	N/A
N/A	Landing Curb? (Y/N)	N/A	N/A	DWS Offset (in)	N/A
N/A	Shared Landing?	N/A			
N/A	Gutter Ponding?	N/A	N/A	Gutter Slope (%)	N/A
N/A	Gutter Lip Ht (in)	N/A	N/A	Gutter X Slope (%)	N/A
N/A	Painted X Walk1?	No	N/A	Painted X Walk2?	No
	X Walk 1 Direction	To N		X Walk 2 Direction	To W
N/A	X Walk 1 Width (in)	N/A	N/A	X Walk 2 Width (in)	N/A
	X Walk 1 Slope (%)	2.5		X Walk 2 Slope (%)	0.5
	X Walk 1 X Slope (%)	2.9		X Walk 2 X Slope (%)	1.5

N/A	Ramp inside XWalk1?	N/A	N/A	Ramp inside XWalk2?	N/A
	Road Slope (%)	0.7	N/A	Clear Space?	N/A
	Road X Slope (%)	5.6	N/A	Clear Space to XWalk (in)	N/A
N/A	Any Obstructions?	N/A	N/A	Storm Grate/Utility Hazard?	N/A
	Obstruction Type			Storm Grate/Utility Type	
		N/A			N/A
		Yes		Surface Condition? (G/P)	Good

**Remove & Replace Curb Ramp With Two New Directional Ramps or Equivalent.**

**Not Found, R304.5.1**
