## **Access Compliance Report Public Rights-of-Way** (Curb Ramps)

Intersection ID: N/A Main Street: WINDSOR\_GATE\_LN Cross Street: W T HARRIS BV Location: NW ADA ID: 1D03DC326C40 Ramp Type: PerpDiag Initial Pass/Fail: Fail **Overall Compliance: No** Severity Score: 13.75

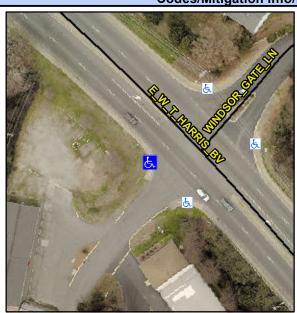
Surveyor Notes: N/A PROW/ADA: Not Found, R304.2.2, R304.5.3 Total Cost: 3200.00

| Compliance Description Data Compliance Description Data | | | | | | |
|---|---|---|---|---|---|---|
| • | N/A Ramp Length (in) | | 63.0 | No | Ramp Slope (%) | 10.8 |
| | Yes | Ramp Length (in) | 56.0 | No | Ramp XSlope (%) | 3.1 |

**Remove & Replace Curb Ramp With** Two New Directional Ramps or Equivalent.
