# Access Compliance Report

## Public Rights-of-Way

### (Curb Ramps)

Intersection ID: 10027080	Main Street: GALLERIA BV	Cross Street: N/A	Location: NE
ADA ID: 1D0A3B41C380	Ramp Type: PerpDiag	Initial Pass/Fail: Fail	Overall Compliance: No
			Severity Score: 33.75

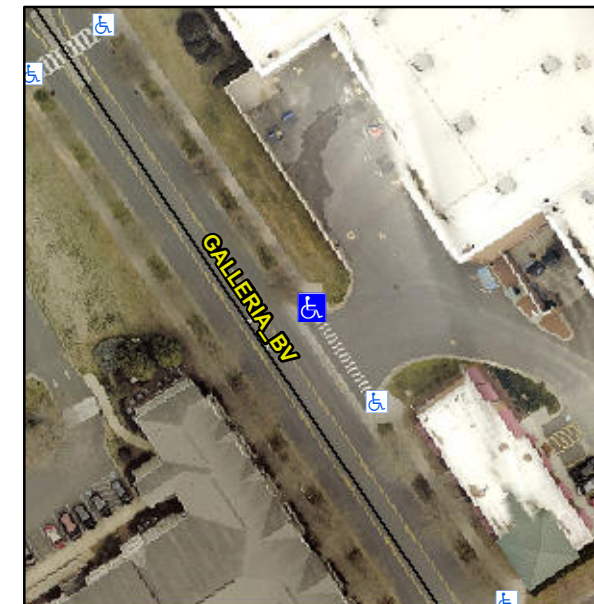
Compliance	Description	Data	Compliance	Description	Data
N/A	Ramp Length (in)	103.0	Yes	Ramp Slope (%)	5.7
No	Ramp Width (in)	39.0	No	Ramp XSlope (%)	7.0
N/A	Flare Type LT	N/A	N/A	Flare Type RT	N/A
N/A	Flare Slope LT (%)	N/A	N/A	Flare Slope RT (%)	N/A
N/A	Flare Traversable LT?	N/A	N/A	Flare Traversable RT?	N/A
N/A	Landing Length (in)	N/A	N/A	DWS Provided?	N/A
N/A	Landing Width (in)	N/A	N/A	DWS Contrast?	N/A
N/A	Landing Slope (%)	N/A	N/A	DWS Length (in)	N/A
N/A	Landing X Slope (%)	N/A	N/A	DWS Full Width?	N/A
N/A	Landing Curb? (Y/N)	N/A	N/A	DWS Offset (in)	N/A
N/A	Shared Landing?	N/A			
N/A	Gutter Ponding?	N/A	N/A	Gutter Slope (%)	N/A
N/A	Gutter Lip Ht (in)	N/A	N/A	Gutter X Slope (%)	N/A
N/A	Painted X Walk1?	No	N/A	Painted X Walk2?	Yes
	X Walk 1 Direction	To SW		X Walk 2 Direction	To SE
N/A	X Walk 1 Width (in)	N/A	N/A	X Walk 2 Width (in)	60.0
	X Walk 1 Slope (%)	9.6		X Walk 2 Slope (%)	0.3
	X Walk 1 X Slope (%)	1.3		X Walk 2 X Slope (%)	8.6

N/A	Ramp inside XWalk1?	N/A	N/A	Ramp inside XWalk2?	Yes
	Road Slope (%)	6.7	N/A	Clear Space?	N/A
	Road X Slope (%)	7.9	N/A	Clear Space to XWalk (in)	N/A
N/A	Any Obstructions?	N/A	N/A	Storm Grate/Utility Hazard?	N/A
	Obstruction Type			Storm Grate/Utility Type	
		N/A			N/A
			Yes	Surface Condition? (G/P)	Good

**Remove & Replace Curb Ramp With Two New Directional Ramps or Equivalent.**

**R304.5.1, R304.5.3**

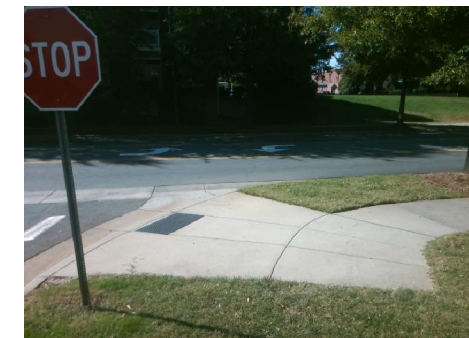
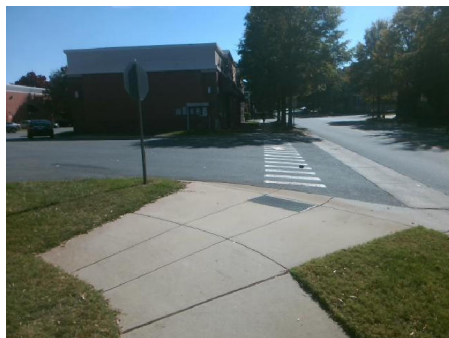
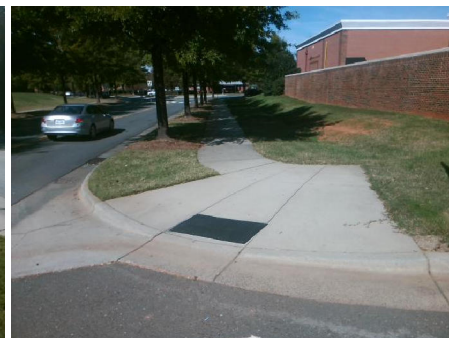
Street 1 Name **GALLERIA BV**  
 Stop Condition-Street 2 **None**  
 Street 2 Name **ENTRANCE**  
 Stop Condition-Street 1 **StopSign**
