## **Access Compliance Report Public Rights-of-Way** (Curb Ramps)

Intersection ID: 10016871 Main Street: PENCE\_RD Cross Street: N/A Location: Overall Compliance: No Initial Pass/Fail: Fail **Severity Score:** 12.5 ADA ID: 1D0A93B372E6 Ramp Type: Perp

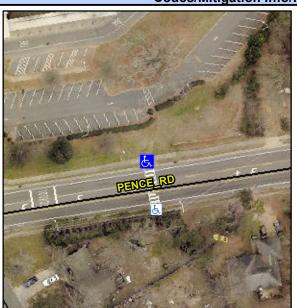
Field Measurements/Component Compliance					
Comp	liance Description	Data	Comp	liance Description	Data
N/A	Ramp Length (in)	48.5	No	Ramp Slope (%)	9.2
Yes	Ramp Width (in)	60.0	Yes	Ramp XSlope (%)	0.8
N/A	Flare Type LT	N/A	N/A	Flare Type RT	N/A
N/A	Flare Slope LT (%)	N/A	N/A	Flare Slope RT (%)	N/A
N/A	Flare Traversable LT?	N/A	N/A	Flare Traversable RT?	N/A
N/A	Landing Length (in)	N/A	N/A	DWS Provided?	N/A
N/A	Landing Width (in)	N/A	N/A	DWS Contrast?	N/A
N/A	Landing Slope (%)	N/A	N/A	DWS Length (in)	N/A
N/A	Landing X Slope (%)	N/A	N/A	DWS Full Width?	N/A
N/A	Landing Curb? (Y/N)	N/A	N/A	DWS Offset (in)	N/A
N/A	Shared Landing?	N/A			
N/A	Gutter Ponding?	N/A	N/A	Gutter Slope (%)	N/A
N/A	Gutter Lip Ht (in)	N/A	N/A	Gutter X Slope (%)	N/A
N/A	Painted X Walk1?	Yes	N/A	Painted X Walk2?	N/A
	X Walk 1 Direction	To S		X Walk 2 Direction	N/A
N/A	X Walk 1 Width (in)	108.0	N/A	X Walk 2 Width (in)	N/A
	X Walk 1 Slope (%)	3.0		X Walk 2 Slope (%)	N/A

X Walk 1 X Slope (%)	0.9		X Walk 2 X Slope (%)	N/A
N/A	Ramp inside XWalk1?	Yes	N/A	Ramp inside XWalk2?	N/A
	Road Slope (%)	N/A	N/A	Clear Space?	N/A
	Road X Slope (%)	N/A	N/A	Clear Space to XWalk (in)	N/A
N/A	Any Obstructions?	N/A	N/A	Storm Grate/Utility Hazard?	N/A
	Obstruction Type			Storm Grate/Utility Type	
		N/A			N/A
			Yes	Surface Condition? (G/P)	Good

Possible Solution	
Possible Solutions:	<u>c</u>
Remove & Replace Entire Ramp.	
·	Υ
	N
	N
	N
	N
Surveyor Notes:	N
N/A	N
	N
	N
	N
PROW/ADA:	N
Not Found, R304.2.2	N
	N
	N

Total Cost:	\$ 1850.00
