# Access Compliance Report

## Public Rights-of-Way

### (Curb Ramps)

| Intersection ID: 11838 | Main Street: MECKLENBURG_AV | Cross Street: FORT_ST | Location: E |

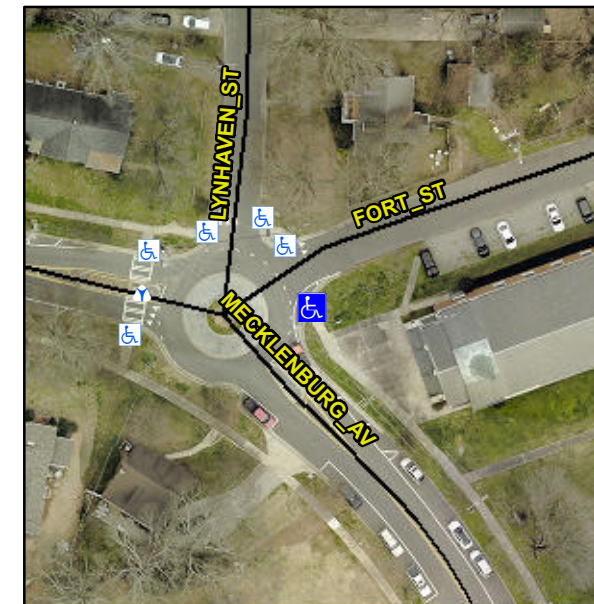
| ADA ID: 1D11EA636C57 | Ramp Type: Directional1 | Initial Pass/Fail: Pass | Overall Compliance: No |
| Severity Score: 0.25 | | | |

**R304.5.3, R304.2.2-Perp, R304.3.2-Para**

| Compliance | Description | Data | Compliance | Description | Data |
|---|---|---|---|---|---|
| No | Ramp XSlope (%) | 3.5 | | | |
| No | Landing Slope (%) | 2.8 | Yes | DWS Length (in) | 24.0 |
| Yes | Gutter Lip Ht (in) | 0.0 | No | Gutter X Slope (%) | 3.5 |

**Remove & Replace Entire Ramp.  
Remove & Replace Gutter.**

Total Cost: \$ 2350.00
