Access Compliance Report

Public Rights-of-Way

(Curb Ramps)

Intersection ID: 4677	Main Street: OLD_STATESVILLE_RD	Cross Street: HENDERSON_RD	Location:	E
ADA ID: 1D20D2DBF695	Ramp Type: Perp	Initial Pass/Fail: Fail	Overall Compliance: No	Severity Score: 10

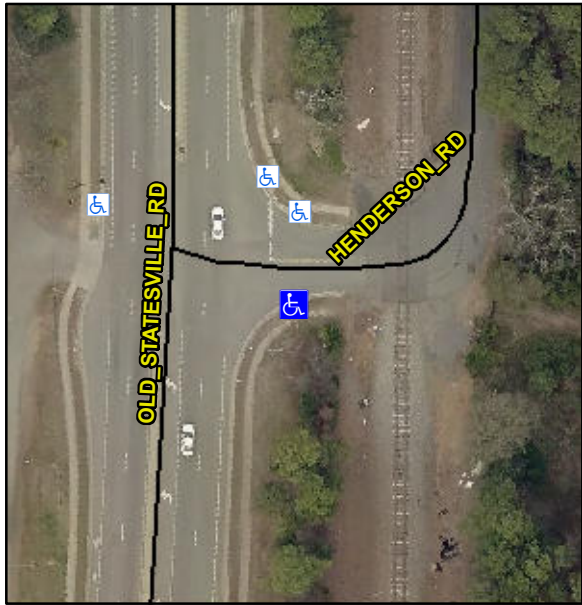
Possible Solutions:		Compliance	Description	Data	Compliance	Description	Data
	Remove & Replace Entire Ramp.		N/A	Ramp Length (in)	60.0	Yes	Ramp Slope (%)	8.2
			No	Ramp Width (in)	45.5	No	Ramp XSlope (%)	3.5
			N/A	Flare Type LT	N/A	N/A	Flare Type RT	N/A
			N/A	Flare Slope LT (%)	N/A	N/A	Flare Slope RT (%)	N/A
			N/A	Flare Traversable LT?	N/A	N/A	Flare Traversable RT?	N/A
			N/A	Landing Length (in)	N/A	N/A	DWS Provided?	N/A
			N/A	Landing Width (in)	N/A	N/A	DWS Contrast?	N/A
			N/A	Landing Slope (%)	N/A	N/A	DWS Length (in)	N/A
			N/A	Landing X Slope (%)	N/A	N/A	DWS Full Width?	N/A
Surveyor Notes:	N/A		N/A	Landing Curb? (Y/N)	N/A	N/A	DWS Offset (in)	N/A
			N/A	Shared Landing?	N/A			
	PROW/ADA:		N/A	Gutter Ponding?	N/A	N/A	Gutter Slope (%)	N/A
	Not Found, R304.5.1, R304.5.3		N/A	Gutter Lip Ht (in)	N/A	N/A	Gutter X Slope (%)	N/A

N/A	Painted X Walk1?	No	N/A	Painted X Walk2?	N/A
				X Walk 1 Direction	To N		X Walk 2 Direction	N/A
			N/A	X Walk 1 Width (in)	N/A	N/A	X Walk 2 Width (in)	N/A
				X Walk 1 Slope (%)	1.3		X Walk 2 Slope (%)	N/A
				X Walk 1 X Slope (%)	3.6		X Walk 2 X Slope (%)	N/A
			N/A	Ramp inside XWalk1?	N/A	N/A	Ramp inside XWalk2?	N/A
			Road Slope (%)	N/A	N/A	Clear Space?	N/A	
			Road X Slope (%)	N/A	N/A	Clear Space to XWalk (in)	N/A	
		N/A	Any Obstructions?	N/A	N/A	Storm Grate/Utility Hazard?	N/A	
			Obstruction Type			Storm Grate/Utility Type		
					N/A		N/A	
						Yes	Surface Condition? (G/P)	Good
Total Cost:		\$ 1850.00
