Access Compliance Report

Public Rights-of-Way

(Curb Ramps)

Intersection ID: 14530	Main Street: E_5TH_ST	Cross Street: N_LAUREL_AV	Location: W
ADA ID: 1D293C9341C4	Ramp Type: Perp	Initial Pass/Fail: Fail	Overall Compliance: No
		Severity Score: 10

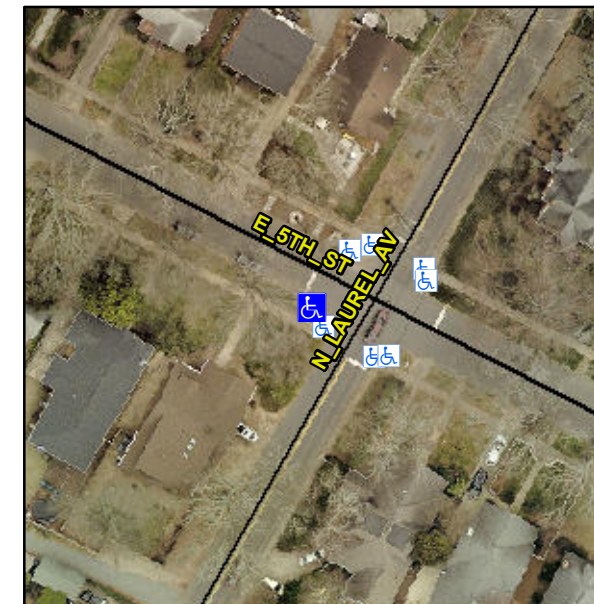
Compliance	Description	Data	Compliance	Description	Data
N/A	Ramp Length (in)	58.0	Yes	Ramp Slope (%)	5.1
No	Ramp Width (in)	45.0	No	Ramp XSlope (%)	2.6
N/A	Flare Type LT	N/A	N/A	Flare Type RT	N/A
N/A	Flare Slope LT (%)	N/A	N/A	Flare Slope RT (%)	N/A
N/A	Flare Traversable LT?	N/A	N/A	Flare Traversable RT?	N/A
N/A	Landing Length (in)	N/A	N/A	DWS Provided?	N/A
N/A	Landing Width (in)	N/A	N/A	DWS Contrast?	N/A
N/A	Landing Slope (%)	N/A	N/A	DWS Length (in)	N/A
N/A	Landing X Slope (%)	N/A	N/A	DWS Full Width?	N/A
N/A	Landing Curb? (Y/N)	N/A	N/A	DWS Offset (in)	N/A
N/A	Shared Landing?	N/A			
N/A	Gutter Ponding?	N/A	N/A	Gutter Slope (%)	N/A
N/A	Gutter Lip Ht (in)	N/A	N/A	Gutter X Slope (%)	N/A
N/A	Painted X Walk1?	No	N/A	Painted X Walk2?	N/A
	X Walk 1 Direction	To NE		X Walk 2 Direction	N/A
N/A	X Walk 1 Width (in)	N/A	N/A	X Walk 2 Width (in)	N/A
	X Walk 1 Slope (%)	2.6		X Walk 2 Slope (%)	N/A
	X Walk 1 X Slope (%)	0.4		X Walk 2 X Slope (%)	N/A

N/A	Ramp inside XWalk1?	N/A	N/A	Ramp inside XWalk2?	N/A
	Road Slope (%)	N/A	N/A	Clear Space?	N/A
	Road X Slope (%)	N/A	N/A	Clear Space to XWalk (in)	N/A
N/A	Any Obstructions?	N/A	N/A	Storm Grate/Utility Hazard?	N/A
	Obstruction Type			Storm Grate/Utility Type	
		N/A			N/A
			Yes	Surface Condition? (G/P)	Good

Possible Solutions:

Remove & Replace Entire Ramp.

R304.5.1, R304.5.3
