# Access Compliance Report

## Public Rights-of-Way

### (Curb Ramps)

Intersection ID: 12916	Main Street: COMMERCE_ST	Cross Street: S_GRAHAM_ST	Location: S
ADA ID: 1D31A494D3C1	Ramp Type: PerpDiag	Initial Pass/Fail: Fail	Overall Compliance: No
Severity Score: 13.75			
Codes/Mitigation Info/Possible Solution		Field Measurements/Component Compliance

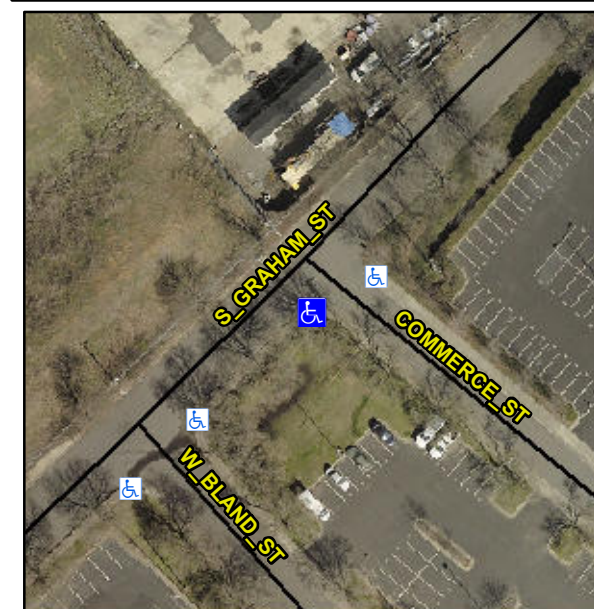
**Not Found, R304.2.2, R304.5.3**

Compliance	Description	Data	Compliance	Description	Data
N/A	Ramp Length (in)	48.0	No	Ramp Slope (%)	8.5
Yes	Ramp Width (in)	48.0	No	Ramp XSlope (%)	3.7
N/A	Flare Type LT	N/A	N/A	Flare Type RT	N/A
N/A	Flare Slope LT (%)	N/A	N/A	Flare Slope RT (%)	N/A
N/A	Flare Traversable LT?	N/A	N/A	Flare Traversable RT?	N/A
N/A	Landing Length (in)	N/A	N/A	DWS Provided?	N/A
N/A	Landing Width (in)	N/A	N/A	DWS Contrast?	N/A
N/A	Landing Slope (%)	N/A	N/A	DWS Length (in)	N/A
N/A	Landing X Slope (%)	N/A	N/A	DWS Full Width?	N/A
N/A	Landing Curb? (Y/N)	N/A	N/A	DWS Offset (in)	N/A
N/A	Shared Landing?	N/A			
N/A	Gutter Ponding?	N/A	N/A	Gutter Slope (%)	N/A
N/A	Gutter Lip Ht (in)	N/A	N/A	Gutter X Slope (%)	N/A
N/A	Painted X Walk1?	No	N/A	Painted X Walk2?	No
	X Walk 1 Direction	To NE		X Walk 2 Direction	To NW
N/A	X Walk 1 Width (in)	N/A	N/A	X Walk 2 Width (in)	N/A
	X Walk 1 Slope (%)	1.4		X Walk 2 Slope (%)	4.3
	X Walk 1 X Slope (%)	3.2		X Walk 2 X Slope (%)	1.2

N/A	Ramp inside XWalk1?	N/A	N/A	Ramp inside XWalk2?	N/A
	Road Slope (%)	2.0	N/A	Clear Space?	N/A
	Road X Slope (%)	2.8	N/A	Clear Space to XWalk (in)	N/A
N/A	Any Obstructions?	N/A	N/A	Storm Grate/Utility Hazard?	N/A
	Obstruction Type			Storm Grate/Utility Type	
		N/A			N/A
		Yes		Surface Condition? (G/P)	Good

**Remove & Replace Curb Ramp With Two New Directional Ramps or Equivalent.**
