Access Compliance Report Public Rights-of-Way (Curb Ramps)

Intersection ID: 44911 Main Street: FOX POINT DR **Cross Street: SPRINGHAVEN DR** Location: W

ADA ID: 1D40273A1A79 Ramp Type: Perp Initial Pass/Fail: Pass **Overall Compliance: No Severity Score:** 7.75

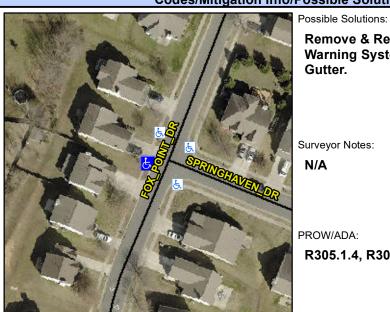
Comp	liance Description	Data	Comp	liance Description	Data
N/A	Ramp Length (in)	48.5	Yes	Ramp Slope (%)	6.7
Yes	Ramp Width (in)	48.0	Yes	Ramp XSlope (%)	2.5
N/A	Flare Type LT	Sloped	N/A	Flare Type RT	N/A
N/A	Flare Slope LT (%)	0.7	N/A	Flare Slope RT (%)	5.9
N/A	Flare Traversable LT?	No	N/A	Flare Traversable RT?	No
Yes	Landing Length (in)	48.0	Yes	DWS Provided?	Yes
Yes	Landing Width (in)	52.5	Yes	DWS Contrast?	Yes
Yes	Landing Slope (%)	1.2	Yes	DWS Length (in)	25.5
Yes	Landing X Slope (%)	2.5	No	DWS Full Width?	No
N/A	Landing Curb? (Y/N)	No	Yes	DWS Offset (in)	1.5
N/A	Shared Landing?	No			
Yes	Gutter Ponding?	No	No	Gutter Slope (%)	14.0
Yes	Gutter Lip Ht (in)	0.0	Yes	Gutter X Slope (%)	2.4
N/A	Painted X Walk1?	No	N/A	Painted X Walk2?	N/A
	X Walk 1 Direction	To SE		X Walk 2 Direction	N/A
N/A	X Walk 1 Width (in)	N/A	N/A	X Walk 2 Width (in)	N/A
	X Walk 1 Slope (%)	2.1		X Walk 2 Slope (%)	N/A
	X Walk 1 X Slope (%)	2.7		X Walk 2 X Slope (%)	N/A

N/A	Ramp inside XWalk1?	N/A	N/A	Ramp inside XWalk2?	N/A
	Road Slope (%)	N/A	N/A	Clear Space?	Yes
	Road X Slope (%)	N/A	N/A	Clear Space to XWalk (in)	N/A
Yes	Any Obstructions?	No	Yes	Storm Grate/Utility Hazard?	No
	Obstruction Type			Storm Grate/Utility Type	
		N/A			N/A

Surface Condition? (G/P)

Good

Remove & Replace Detectable Warning System. Remove & Replace Gutter.

R305.1.4, R304.5.4

Total Cost: 1550.00
