Access Compliance Report

Public Rights-of-Way

(Curb Ramps)

Intersection ID: 27841	Main Street: BALLANTYNE_COUNTRY_CLUB_DR	Cross Street: OLD_WAYSIDE_RD	Location: NW
ADA ID: 1D4AB868A55E	Ramp Type: Perp	Initial Pass/Fail: Fail	Overall Compliance: No
Severity Score: 26.25			
Codes/Mitigation Info/Possible Solution		Field Measurements/Component Compliance

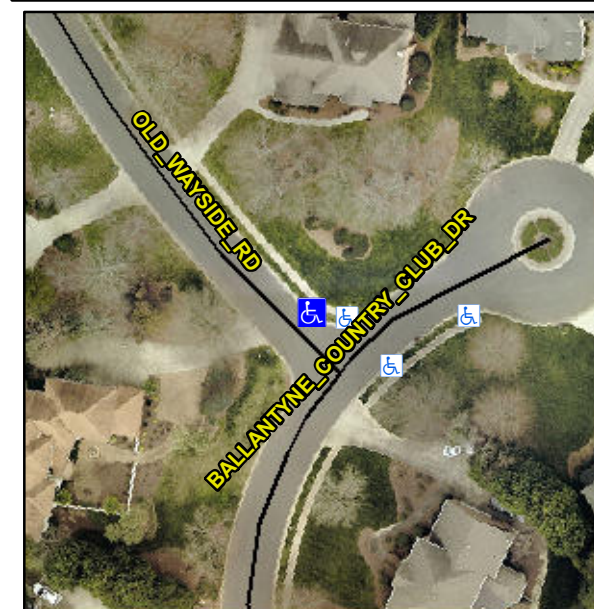
Not Found, R304.2.2, R304.5.3

Compliance	Description	Data	Compliance	Description	Data
N/A	Ramp Length (in)	48.0	No	Ramp Slope (%)	14.6
Yes	Ramp Width (in)	48.0	No	Ramp XSlope (%)	2.3
N/A	Flare Type LT	N/A	N/A	Flare Type RT	N/A
N/A	Flare Slope LT (%)	N/A	N/A	Flare Slope RT (%)	N/A
N/A	Flare Traversable LT?	N/A	N/A	Flare Traversable RT?	N/A
N/A	Landing Length (in)	N/A	N/A	DWS Provided?	N/A
N/A	Landing Width (in)	N/A	N/A	DWS Contrast?	N/A
N/A	Landing Slope (%)	N/A	N/A	DWS Length (in)	N/A
N/A	Landing X Slope (%)	N/A	N/A	DWS Full Width?	N/A
N/A	Landing Curb? (Y/N)	N/A	N/A	DWS Offset (in)	N/A
N/A	Shared Landing?	N/A			
N/A	Gutter Ponding?	N/A	N/A	Gutter Slope (%)	N/A
N/A	Gutter Lip Ht (in)	N/A	N/A	Gutter X Slope (%)	N/A
N/A	Painted X Walk1?	No	N/A	Painted X Walk2?	N/A
	X Walk 1 Direction	To SW		X Walk 2 Direction	N/A
N/A	X Walk 1 Width (in)	N/A	N/A	X Walk 2 Width (in)	N/A
	X Walk 1 Slope (%)	3.3		X Walk 2 Slope (%)	N/A
	X Walk 1 X Slope (%)	2.1		X Walk 2 X Slope (%)	N/A

Remove & Replace Entire Ramp.

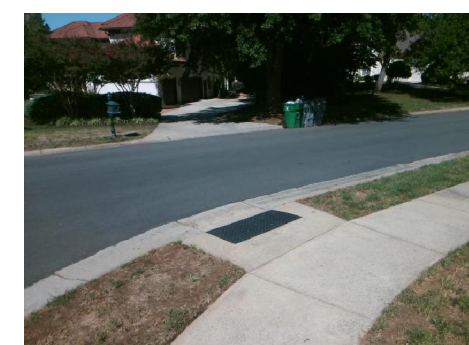
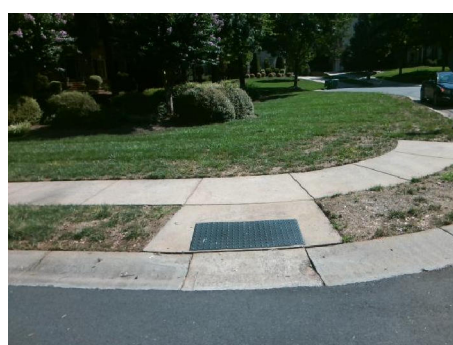
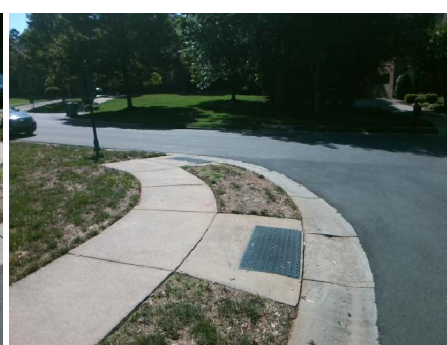
N/A	Ramp inside XWalk1?	N/A	N/A	Ramp inside XWalk2?	N/A
	Road Slope (%)	N/A	N/A	Clear Space?	N/A
	Road X Slope (%)	N/A	N/A	Clear Space to XWalk (in)	N/A
N/A	Any Obstructions?	N/A	N/A	Storm Grate/Utility Hazard?	N/A
	Obstruction Type			Storm Grate/Utility Type	
		N/A			N/A
			Yes	Surface Condition? (G/P)	Good
