# Access Compliance Report

## Public Rights-of-Way

### (Curb Ramps)

| Intersection ID: 31686 | Main Street: GALLISON_AV | Cross Street: SNOWDROP_DR | Location: SW |

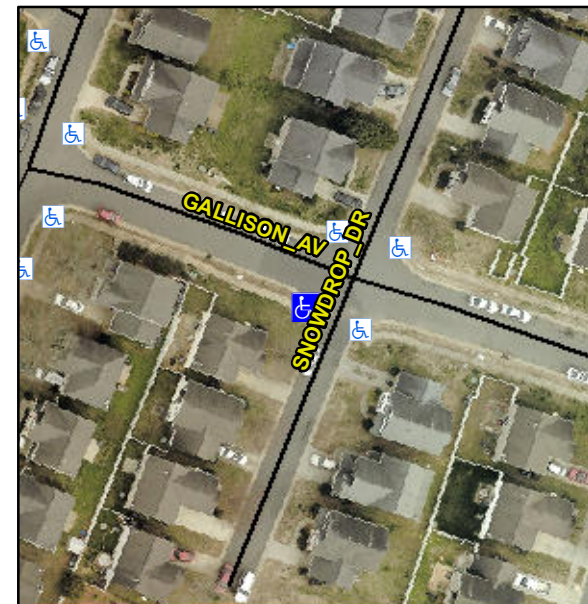
| ADA ID: 1D4D8B4DC825 | Ramp Type: PerpDiag | Initial Pass/Fail: Fail | Overall Compliance: No |

| Compliance | Description | Data | Compliance | Description | Data |
|---|---|---|---|---|---|
| N/A | Ramp Length (in) | 47.0 | Yes | Ramp Slope (%) | 7.2 |
| No | Ramp Width (in) | 37.0 | No | Ramp XSlope (%) | 2.2 |

**Remove & Replace Curb Ramp With Two New Directional Ramps or Equivalent.**

**R304.5.1, R304.5.3**
