Access Compliance Report

Public Rights-of-Way

(Curb Ramps)

Intersection ID: 14535	Main Street: E_KINGSTON_AV	Cross Street: LENNOX_AV	Location: W
ADA ID: 1D563FB69F93	Ramp Type: Perp	Initial Pass/Fail: Fail	Overall Compliance: No
			Severity Score: 13.75

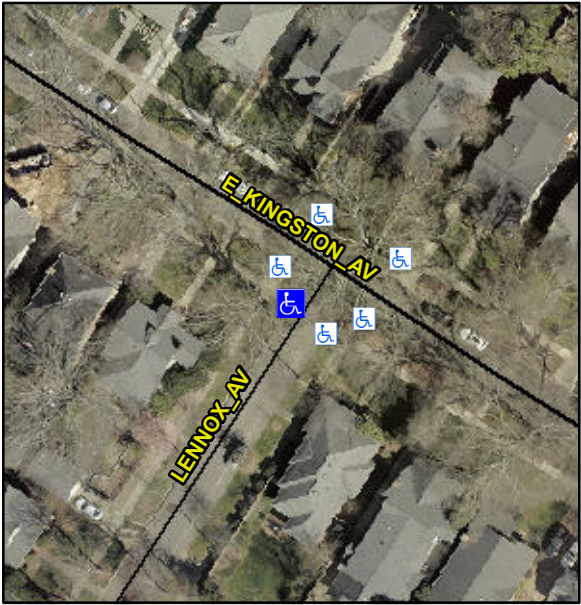
Possible Solutions:		Compliance	Description	Data
	Remove & Replace Entire Ramp.		No	Ramp Length (in)	71.0
			Yes	Ramp Width (in)	48.0
			N/A	Flare Type LT	N/A
			N/A	Flare Slope LT (%)	N/A
			N/A	Flare Traversable LT?	N/A
			N/A	Landing Length (in)	N/A
			N/A	Landing Width (in)	N/A
			N/A	Landing Slope (%)	N/A
			N/A	Landing X Slope (%)	N/A
<p>Surveyor Notes:</p> <p>N/A</p> <p>PROW/ADA:</p> <p>Not Found, R304.2.2, R304.5.3</p>			N/A	Flare Type RT	N/A
			N/A	Flare Slope RT (%)	N/A
			N/A	Flare Traversable RT?	N/A
			N/A	DWS Provided?	N/A
			N/A	DWS Contrast?	N/A
			N/A	DWS Length (in)	N/A
			N/A	DWS Full Width?	N/A
			N/A	DWS Offset (in)	N/A
			N/A	Gutter Ponding?	N/A
			N/A	Gutter Lip Ht (in)	N/A
<p>Total Cost:</p> <p>\$ 1850.00</p>			No	Painted X Walk1?	N/A
			No	X Walk 1 Direction	To SE
			N/A	X Walk 1 Width (in)	N/A

0.8	X Walk 1 Slope (%)	N/A
			3.4	X Walk 1 X Slope (%)	N/A
			N/A	Ramp inside XWalk1?	N/A
			N/A	Road Slope (%)	N/A
			N/A	Road X Slope (%)	N/A
			N/A	Any Obstructions?	N/A
			N/A	Obstruction Type	N/A
			N/A	Clear Space?	N/A
			N/A	Clear Space to XWalk (in)	N/A
			N/A	Storm Grate/Utility Hazard?	N/A
			N/A	Storm Grate/Utility Type	N/A
			Yes	Surface Condition? (G/P)	Good
