Access Compliance Report

Public Rights-of-Way

(Curb Ramps)

Intersection ID: 23662	Main Street: CARMEL_RD	Cross Street: RED_OAK_LN	Location: SW
ADA ID: 1D5D58B42504	Ramp Type: PerpDiag	Initial Pass/Fail: Fail	Overall Compliance: No Severity Score: 33.75

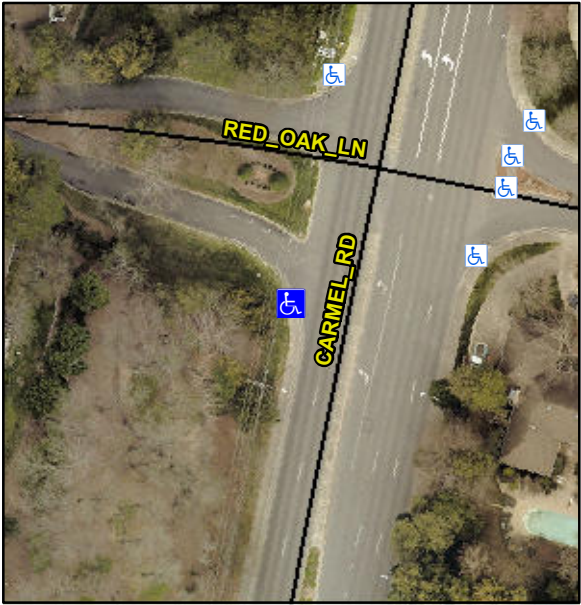
Possible Solutions:		Compliance	Description	Data
	Remove & Replace Curb Ramp With Two New Directional Ramps or Equivalent.		No	Ramp Length (in)	59.0
			No	Ramp Width (in)	47.5
			N/A	Flare Type LT	N/A
			N/A	Flare Slope LT (%)	N/A
			N/A	Flare Traversable LT?	N/A
			N/A	Landing Length (in)	N/A
			N/A	Landing Width (in)	N/A
			N/A	Landing Slope (%)	N/A
			N/A	Landing X Slope (%)	N/A
<p>Surveyor Notes:</p> <p>N/A</p> <p>PROW/ADA:</p> <p>R304.5.1, R304.2.2, R304.5.3</p>			N/A	Flare Type RT	N/A
			N/A	Flare Slope RT (%)	N/A
			N/A	Flare Traversable RT?	N/A
			N/A	DWS Provided?	N/A
			N/A	DWS Contrast?	N/A
			N/A	DWS Length (in)	N/A
			N/A	DWS Full Width?	N/A
			N/A	DWS Offset (in)	N/A
			N/A	Gutter Ponding?	N/A
			N/A	Gutter Lip Ht (in)	N/A
<p>Total Cost:</p> <p>\$ 3200.00</p>			No	Painted X Walk1?	No
			To N	X Walk 2 Direction	To E

N/A	X Walk 2 Width (in)	N/A
			7.7	X Walk 2 Slope (%)	2.8
			0.5	X Walk 2 X Slope (%)	4.4
			N/A	Ramp inside XWalk2?	N/A
			2.0	Clear Space?	N/A
			5.2	Clear Space to XWalk (in)	N/A
			N/A	Storm Grate/Utility Hazard?	N/A
			N/A	Storm Grate/Utility Type	N/A
<p>Obstruction Type</p>			N/A	Surface Condition? (G/P)	Good
