Access Compliance Report

Public Rights-of-Way

(Curb Ramps)

Intersection ID: N/A	Main Street: BEREWICK COMMONS PKY	Cross Street: LANGWELL LN	Location: W
ADA ID: 1D999BF63442	Ramp Type: Perp	Initial Pass/Fail: Fail	Overall Compliance: No
Severity Score: 33.75			
Codes/Mitigation Info/Possible Solution		Field Measurements/Component Compliance

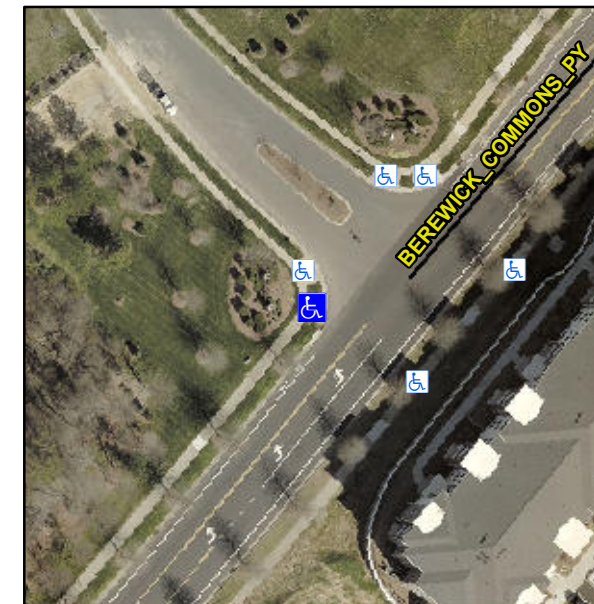
Compliance	Description	Data	Compliance	Description	Data
N/A	Ramp Length (in)	81.0	No	Ramp Slope (%)	9.7
No	Ramp Width (in)	41.0	No	Ramp XSlope (%)	6.2
N/A	Flare Type LT	N/A	N/A	Flare Type RT	N/A
N/A	Flare Slope LT (%)	N/A	N/A	Flare Slope RT (%)	N/A
N/A	Flare Traversable LT?	N/A	N/A	Flare Traversable RT?	N/A
N/A	Landing Length (in)	N/A	N/A	DWS Provided?	N/A
N/A	Landing Width (in)	N/A	N/A	DWS Contrast?	N/A
N/A	Landing Slope (%)	N/A	N/A	DWS Length (in)	N/A
N/A	Landing X Slope (%)	N/A	N/A	DWS Full Width?	N/A
N/A	Landing Curb? (Y/N)	N/A	N/A	DWS Offset (in)	N/A
N/A	Shared Landing?	N/A			
N/A	Gutter Ponding?	N/A	N/A	Gutter Slope (%)	N/A
N/A	Gutter Lip Ht (in)	N/A	N/A	Gutter X Slope (%)	N/A
N/A	Painted X Walk1?	No	N/A	Painted X Walk2?	N/A
	X Walk 1 Direction	To SE		X Walk 2 Direction	N/A
N/A	X Walk 1 Width (in)	N/A	N/A	X Walk 2 Width (in)	N/A
	X Walk 1 Slope (%)	3.5		X Walk 2 Slope (%)	N/A
	X Walk 1 X Slope (%)	4.4		X Walk 2 X Slope (%)	N/A

N/A	Ramp inside XWalk1?	N/A	N/A	Ramp inside XWalk2?	N/A
	Road Slope (%)	N/A	N/A	Clear Space?	N/A
	Road X Slope (%)	N/A	N/A	Clear Space to XWalk (in)	N/A
N/A	Any Obstructions?	N/A	N/A	Storm Grate/Utility Hazard?	N/A
	Obstruction Type			Storm Grate/Utility Type	
		N/A			N/A
			Yes	Surface Condition? (G/P)	Good

Possible Solutions:

Remove & Replace Entire Ramp.
