Access Compliance Report

Public Rights-of-Way

(Curb Ramps)

Intersection ID: 32314	Main Street: CAMDEN TRAIL CT	Cross Street: NEW PROVIDENCE LN	Location: SE
ADA ID: 1D9A610E910A	Ramp Type: Perp	Initial Pass/Fail: Fail	Overall Compliance: No
Codes/Mitigation Info/Possible Solution		Field Measurements/Component Compliance	
Severity Score: 21.25

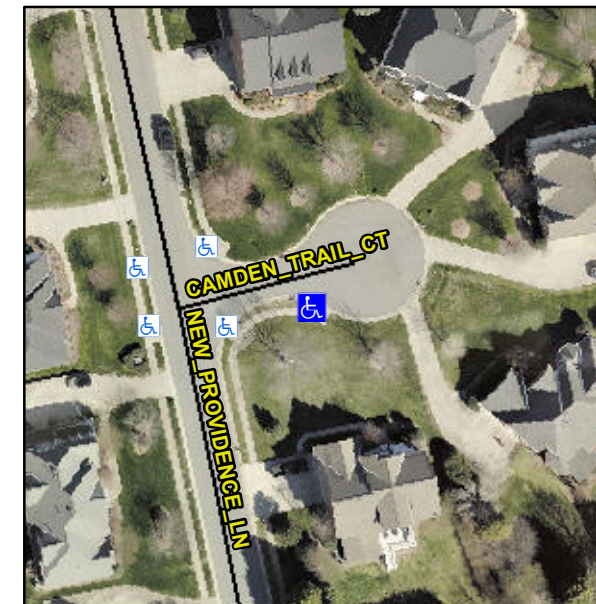
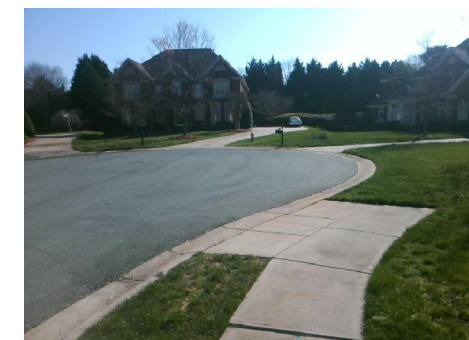
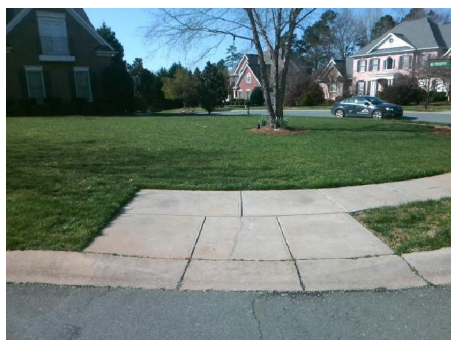
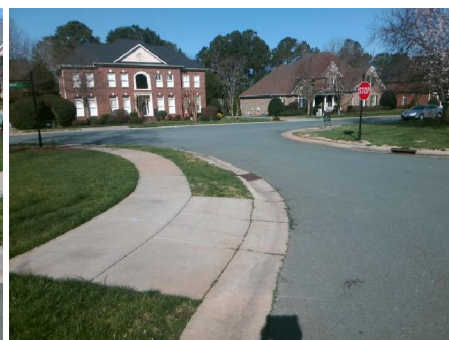
Not Found, R304.5.1, R304.2.2

Compliance	Description	Data	Compliance	Description	Data
N/A	Ramp Length (in)	48.0	No	Ramp Slope (%)	8.5
No	Ramp Width (in)	42.0	Yes	Ramp XSlope (%)	1.9
N/A	Flare Type LT	N/A	N/A	Flare Type RT	N/A
N/A	Flare Slope LT (%)	N/A	N/A	Flare Slope RT (%)	N/A
N/A	Flare Traversable LT?	N/A	N/A	Flare Traversable RT?	N/A
N/A	Landing Length (in)	N/A	N/A	DWS Provided?	N/A
N/A	Landing Width (in)	N/A	N/A	DWS Contrast?	N/A
N/A	Landing Slope (%)	N/A	N/A	DWS Length (in)	N/A
N/A	Landing X Slope (%)	N/A	N/A	DWS Full Width?	N/A
N/A	Landing Curb? (Y/N)	N/A	N/A	DWS Offset (in)	N/A
N/A	Shared Landing?	N/A			
N/A	Gutter Ponding?	N/A	N/A	Gutter Slope (%)	N/A
N/A	Gutter Lip Ht (in)	N/A	N/A	Gutter X Slope (%)	N/A
N/A	Painted X Walk1?	No	N/A	Painted X Walk2?	N/A
	X Walk 1 Direction	To N		X Walk 2 Direction	N/A
N/A	X Walk 1 Width (in)	N/A	N/A	X Walk 2 Width (in)	N/A
	X Walk 1 Slope (%)	1.7		X Walk 2 Slope (%)	N/A
	X Walk 1 X Slope (%)	6.1		X Walk 2 X Slope (%)	N/A

N/A	Ramp inside XWalk1?	N/A	N/A	Ramp inside XWalk2?	N/A
	Road Slope (%)	N/A	N/A	Clear Space?	N/A
	Road X Slope (%)	N/A	N/A	Clear Space to XWalk (in)	N/A
N/A	Any Obstructions?	N/A	N/A	Storm Grate/Utility Hazard?	N/A
	Obstruction Type			Storm Grate/Utility Type	
		N/A			N/A
			Yes	Surface Condition? (G/P)	Good

Possible Solutions:

Remove & Replace Entire Ramp.

Total Cost: \$ 1850.00
